Batteries in Recycling Transport Explosions

How, Why, Prevention, Mitigation

Robert L. Swaim

Birmingham Dry Van (Box) Trailer Case Study

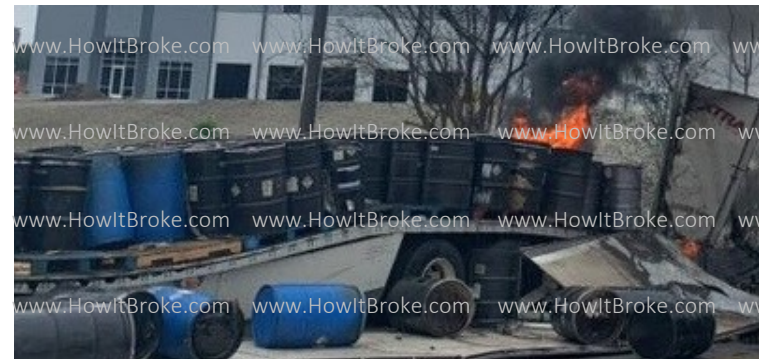
Dry van (box) trailer contained barrels of batteries to be recycled

Driver drove about 1,800 miles from Las Vegas, NV

Parked two days before explosion to visit family

Witnesses reported roof reached 70 feet

Barrels of batteries found marked Class 9

Barrel contents found inadequately packaged

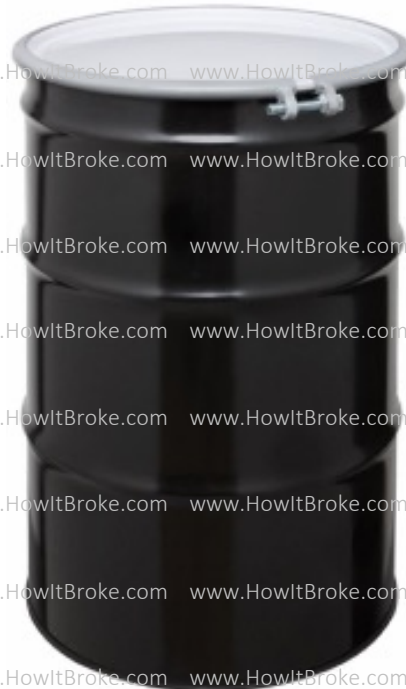
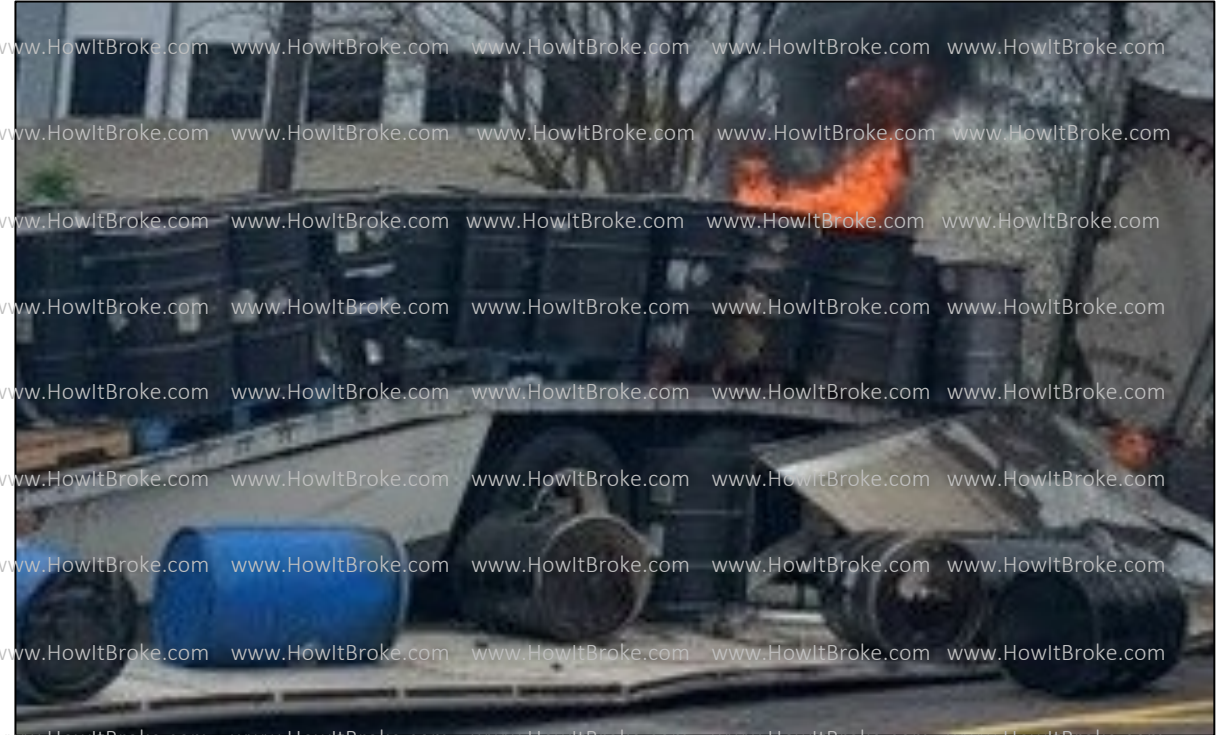
18 drums had fire damage

2 had sand in bottom with loose batteries undergoing thermal runaway on top

1 breached drum near door evidenced gas release

Batteries in most were loose packed

Fail catastrophically at 14+ psi

Leak tests at 5 psi

Lids may bulge at 4 psi

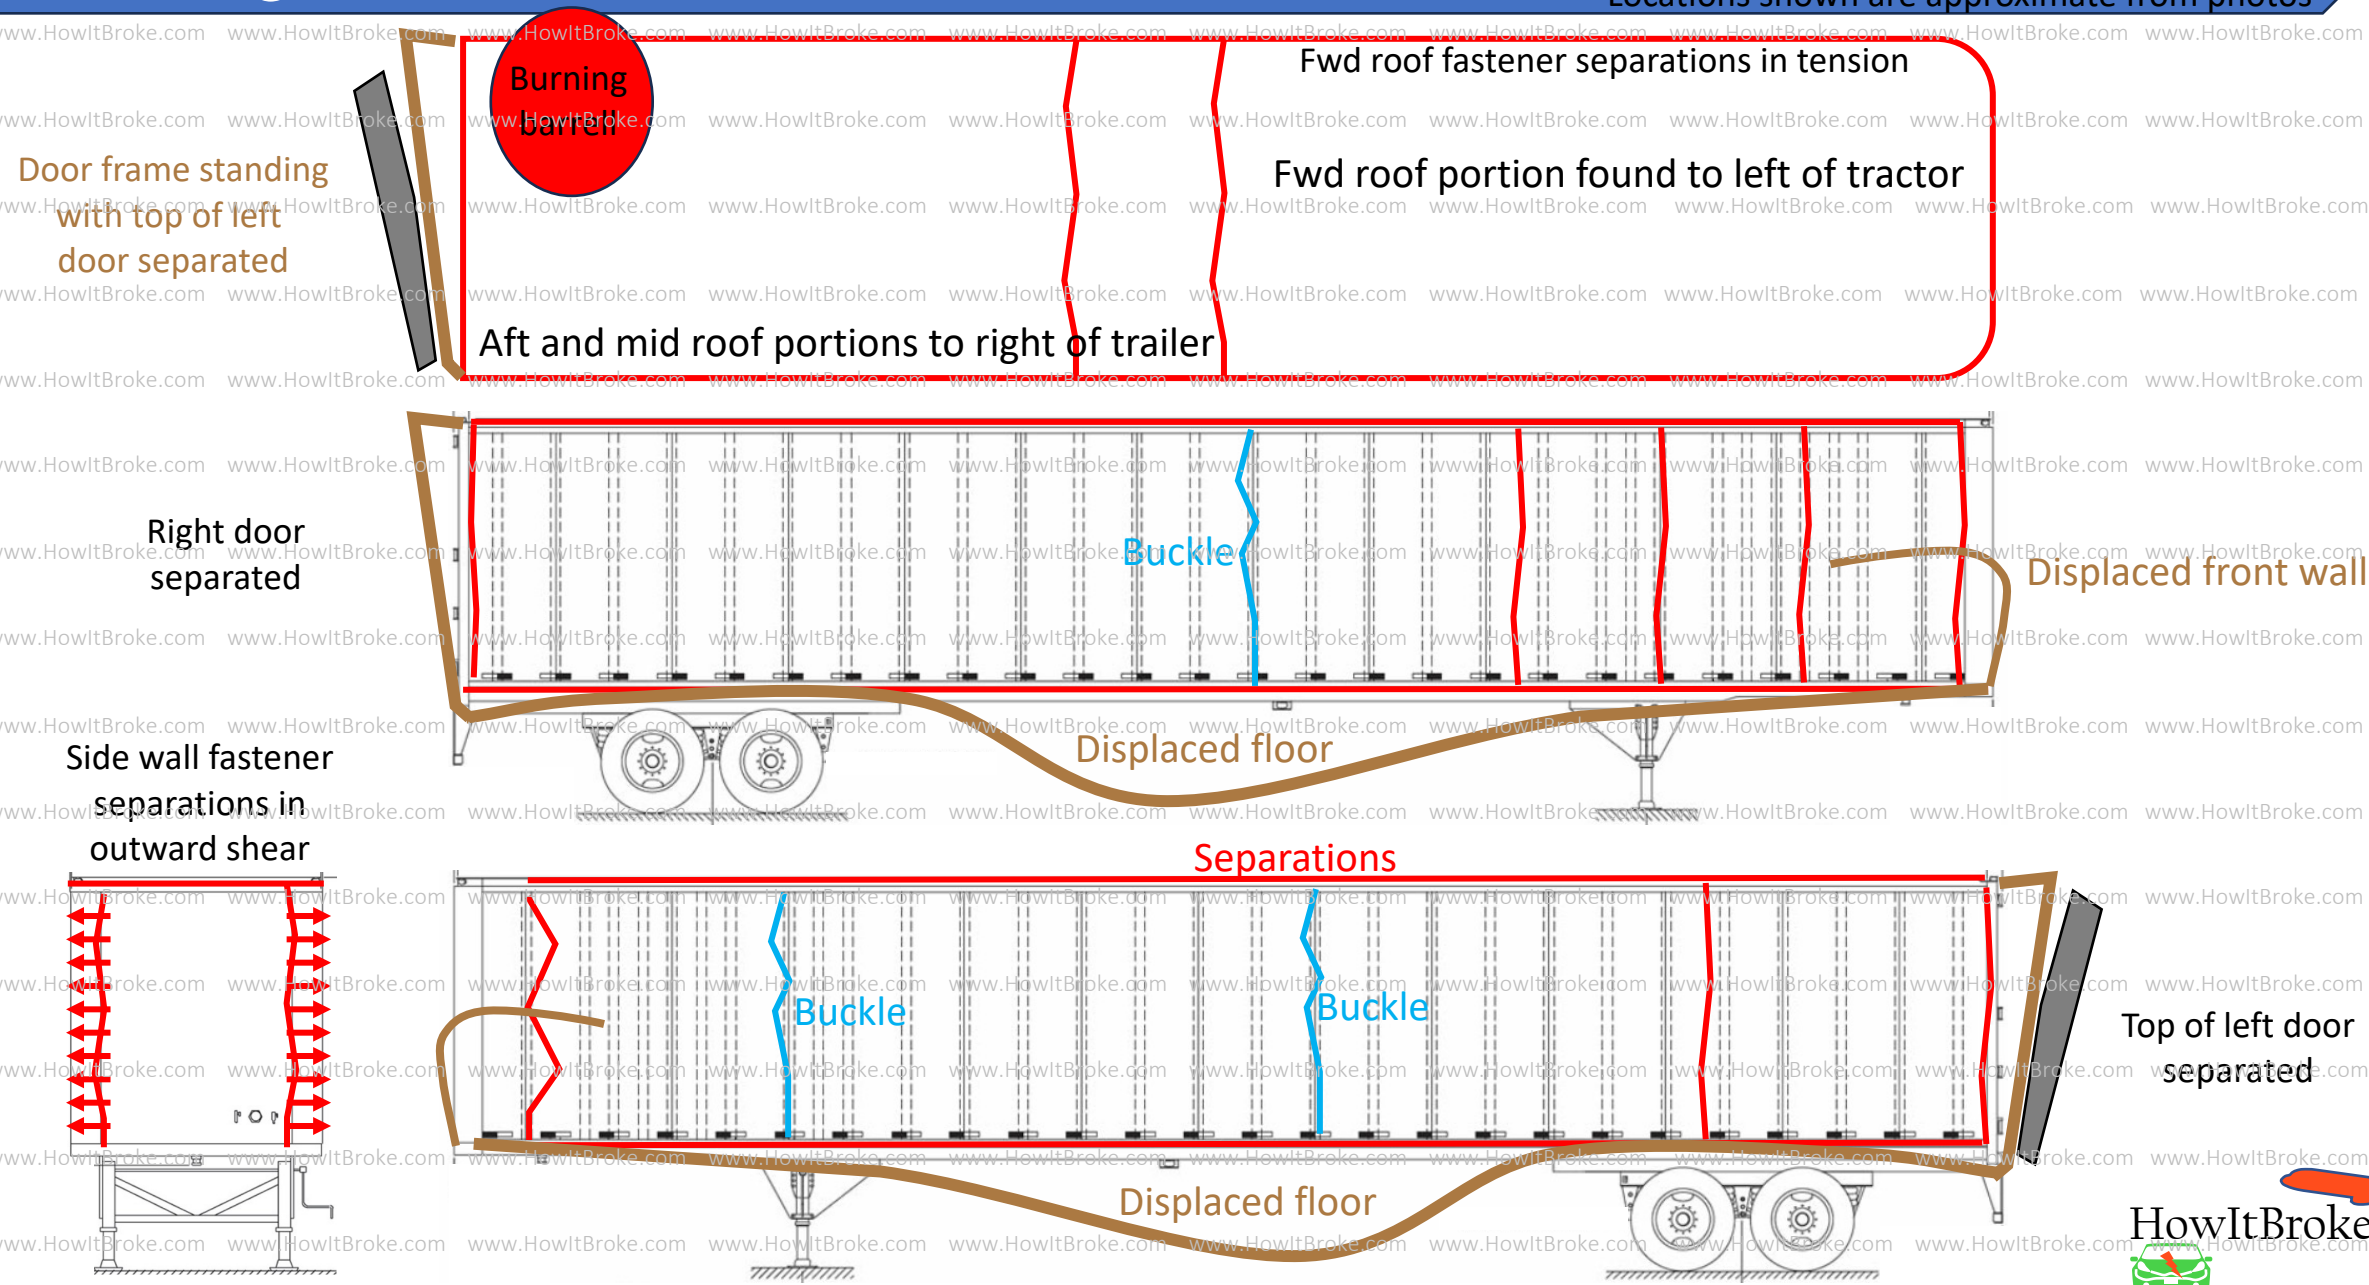
Damage to Trailer

Floor displaced downward to ground ahead of rear wheels

Right rear door separated

Aluminum roof separated into three pieces

Aft third and mid landed to right of trailer

Forward portion landed to left of tractor more damaged

Total separation relatively intact

Tearing from front ragged at front

Aft half folded down from top and remained attached

Forward portions smaller and completely separated

Front wall displaced forward into sleeper compartment of tractor with top folded aft

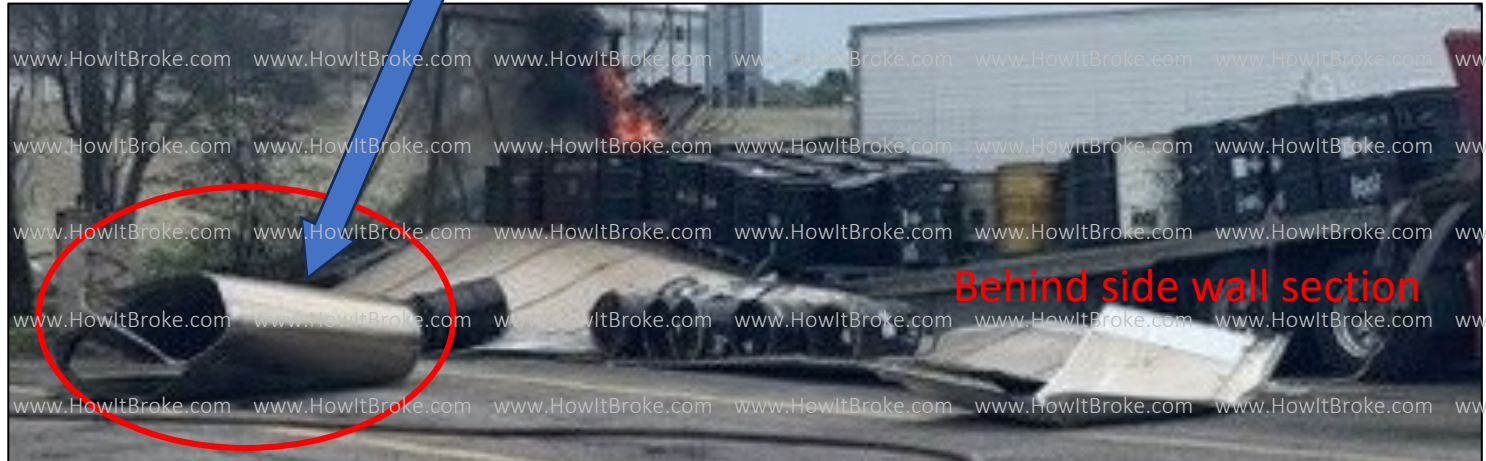
Evidence of Detonation – Roof Sections

Fwd roof fastener separations in tension

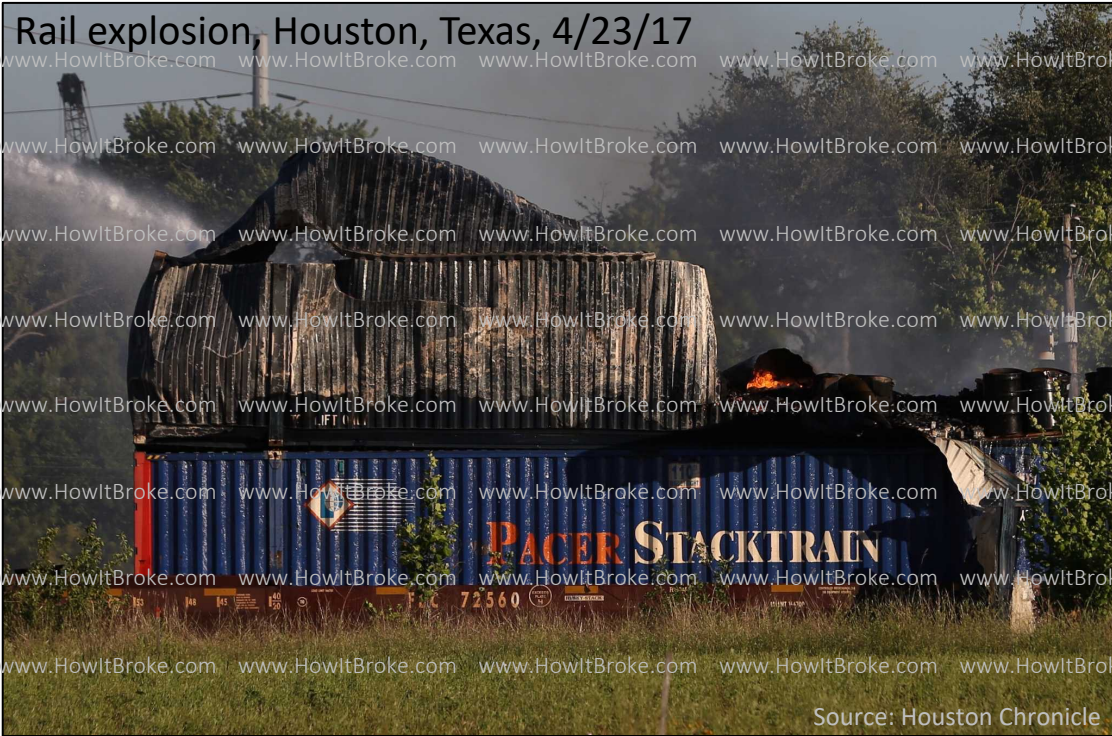
Rail explosion, Houston, Texas, 4/23/17

Upper of two stacked 53 ft Intermodal steel containers
Lithium-ion batteries being sent to recycler
New Orleans to San Antonio
Exploded in downtown Houston
No Haz Mat markings

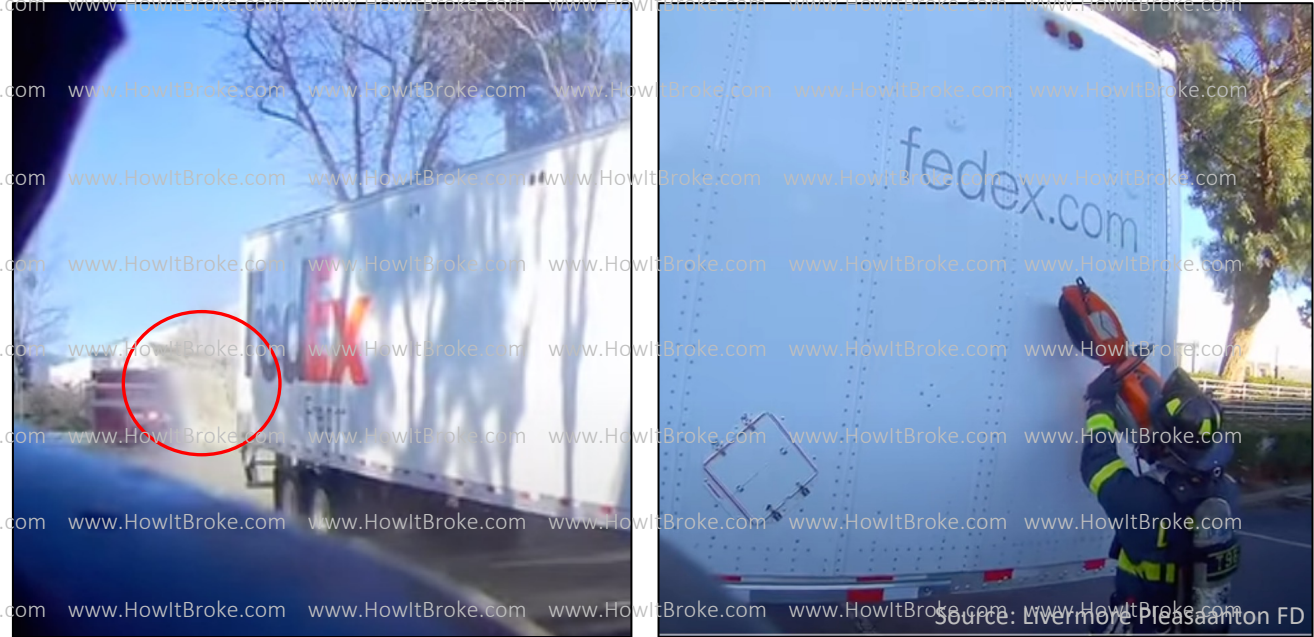
Trailer Door, Livermore Pleasanton, CA, 12/23

53 ft Dry van similar to Birmingham
Partial load of batteries at front of box
Exploded when firefighter used circular saw to vent front
No Haz Mat markings

Note lack of hazardous materials markings
