Addendum No. 1

Date: August 11, 2016

**Project: Restroom Renewal
Longview Readiness Center
Project Number 2015-658
Longview, WA**

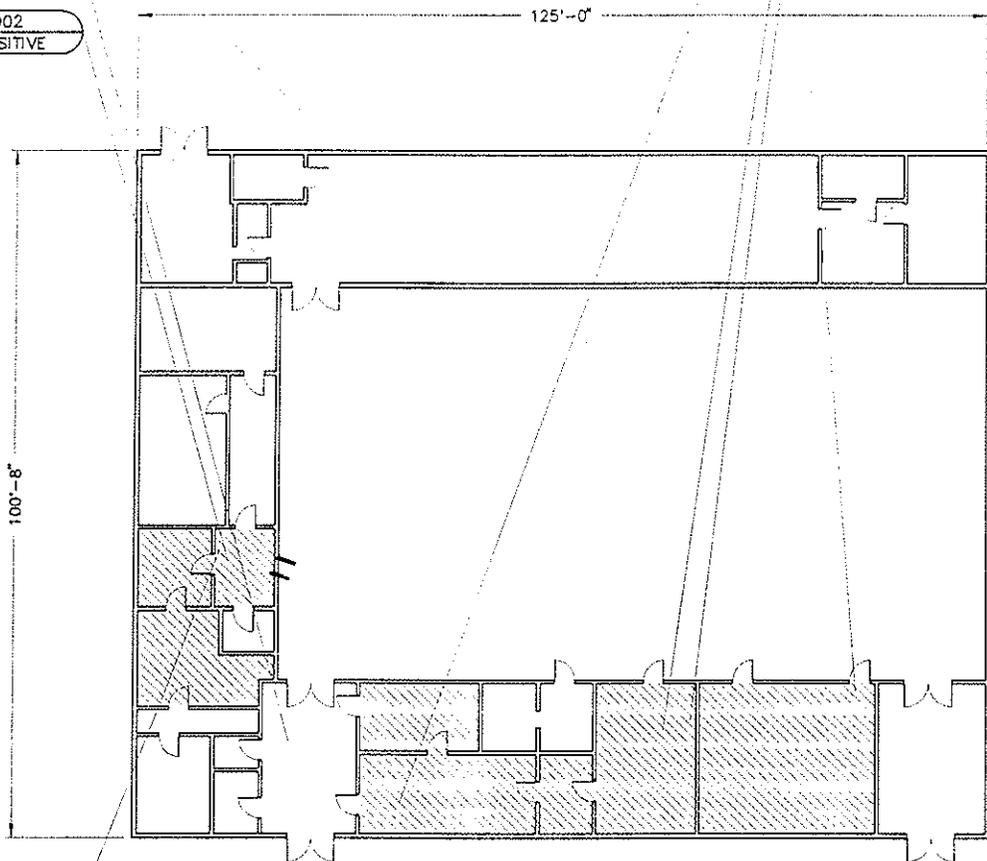
LONGVIEW ARMORY

LON-ARMO-006
OTH | NEGATIVE

LON-ARMO-001
VAT | NEGATIVE

LON-ARMO-002
VAT | POSITIVE

LON-ARMO-007
CBM | NEGATIVE

LON-ARMO-004
ACP | NEGATIVE

LON-ARMO-005
GWB | NEGATIVE

LON-ARMO-003
VAT | POSITIVE

LON-ARMO-008
GWB | NEGATIVE

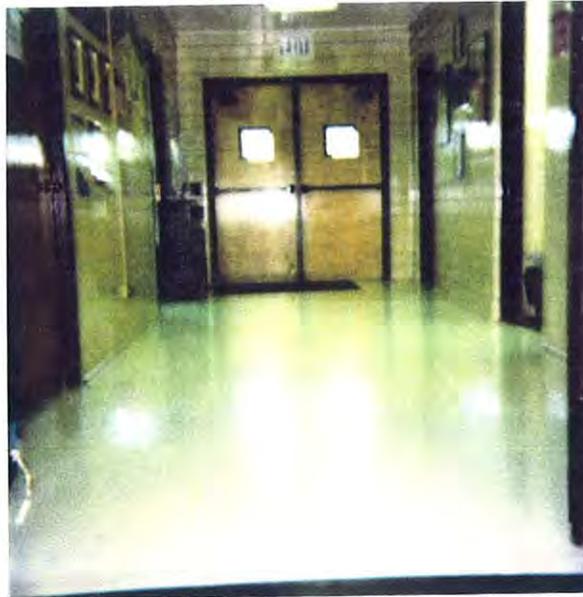
LON-ARMO-001

SOURCE: VAT

LOCATION: HSA 001, bldg. entryway

White tile with light gray streaks

No Asbestos Detected

Note: 12"X12" floor tile

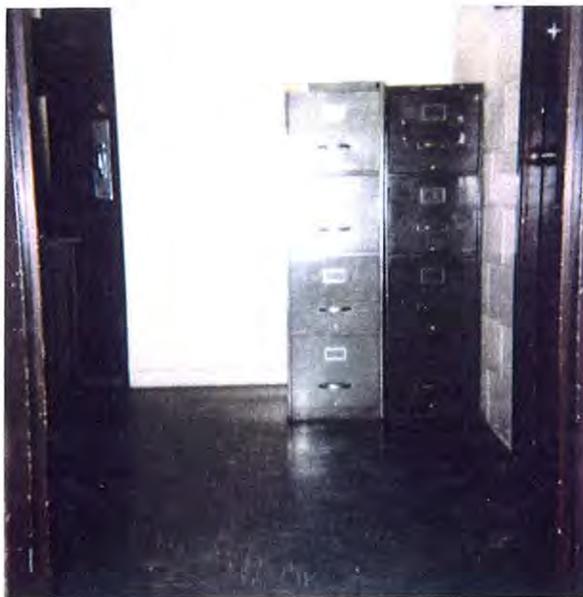
LON-ARMO-002

SOURCE: VAT

LOCATION: HSA 002, near doorway entry # 11

Green tile with light green & white streaks

<i>Asbestos Containing</i>	
<u>ASBESTOS TYPE</u>	<u>PERCENT</u>
Chrysotile	2

Note: 9"X9" floor tile

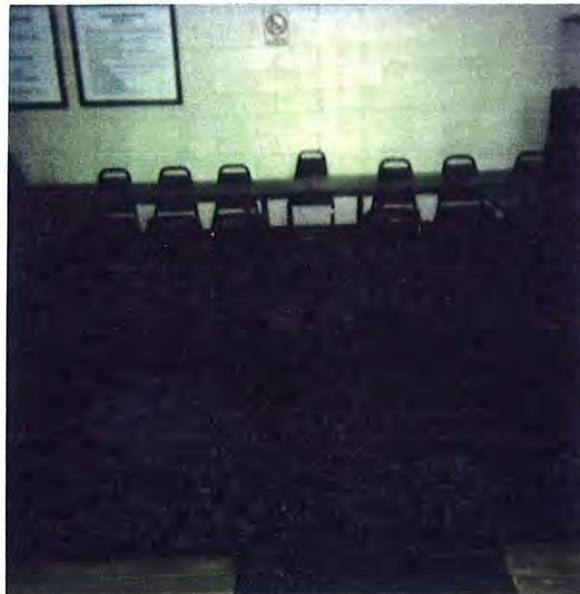
LON-ARMO-003

Vinyl Filler and Binder	93
Non-Fibrous Tremolite	1

Note: 9"X9" floor tile

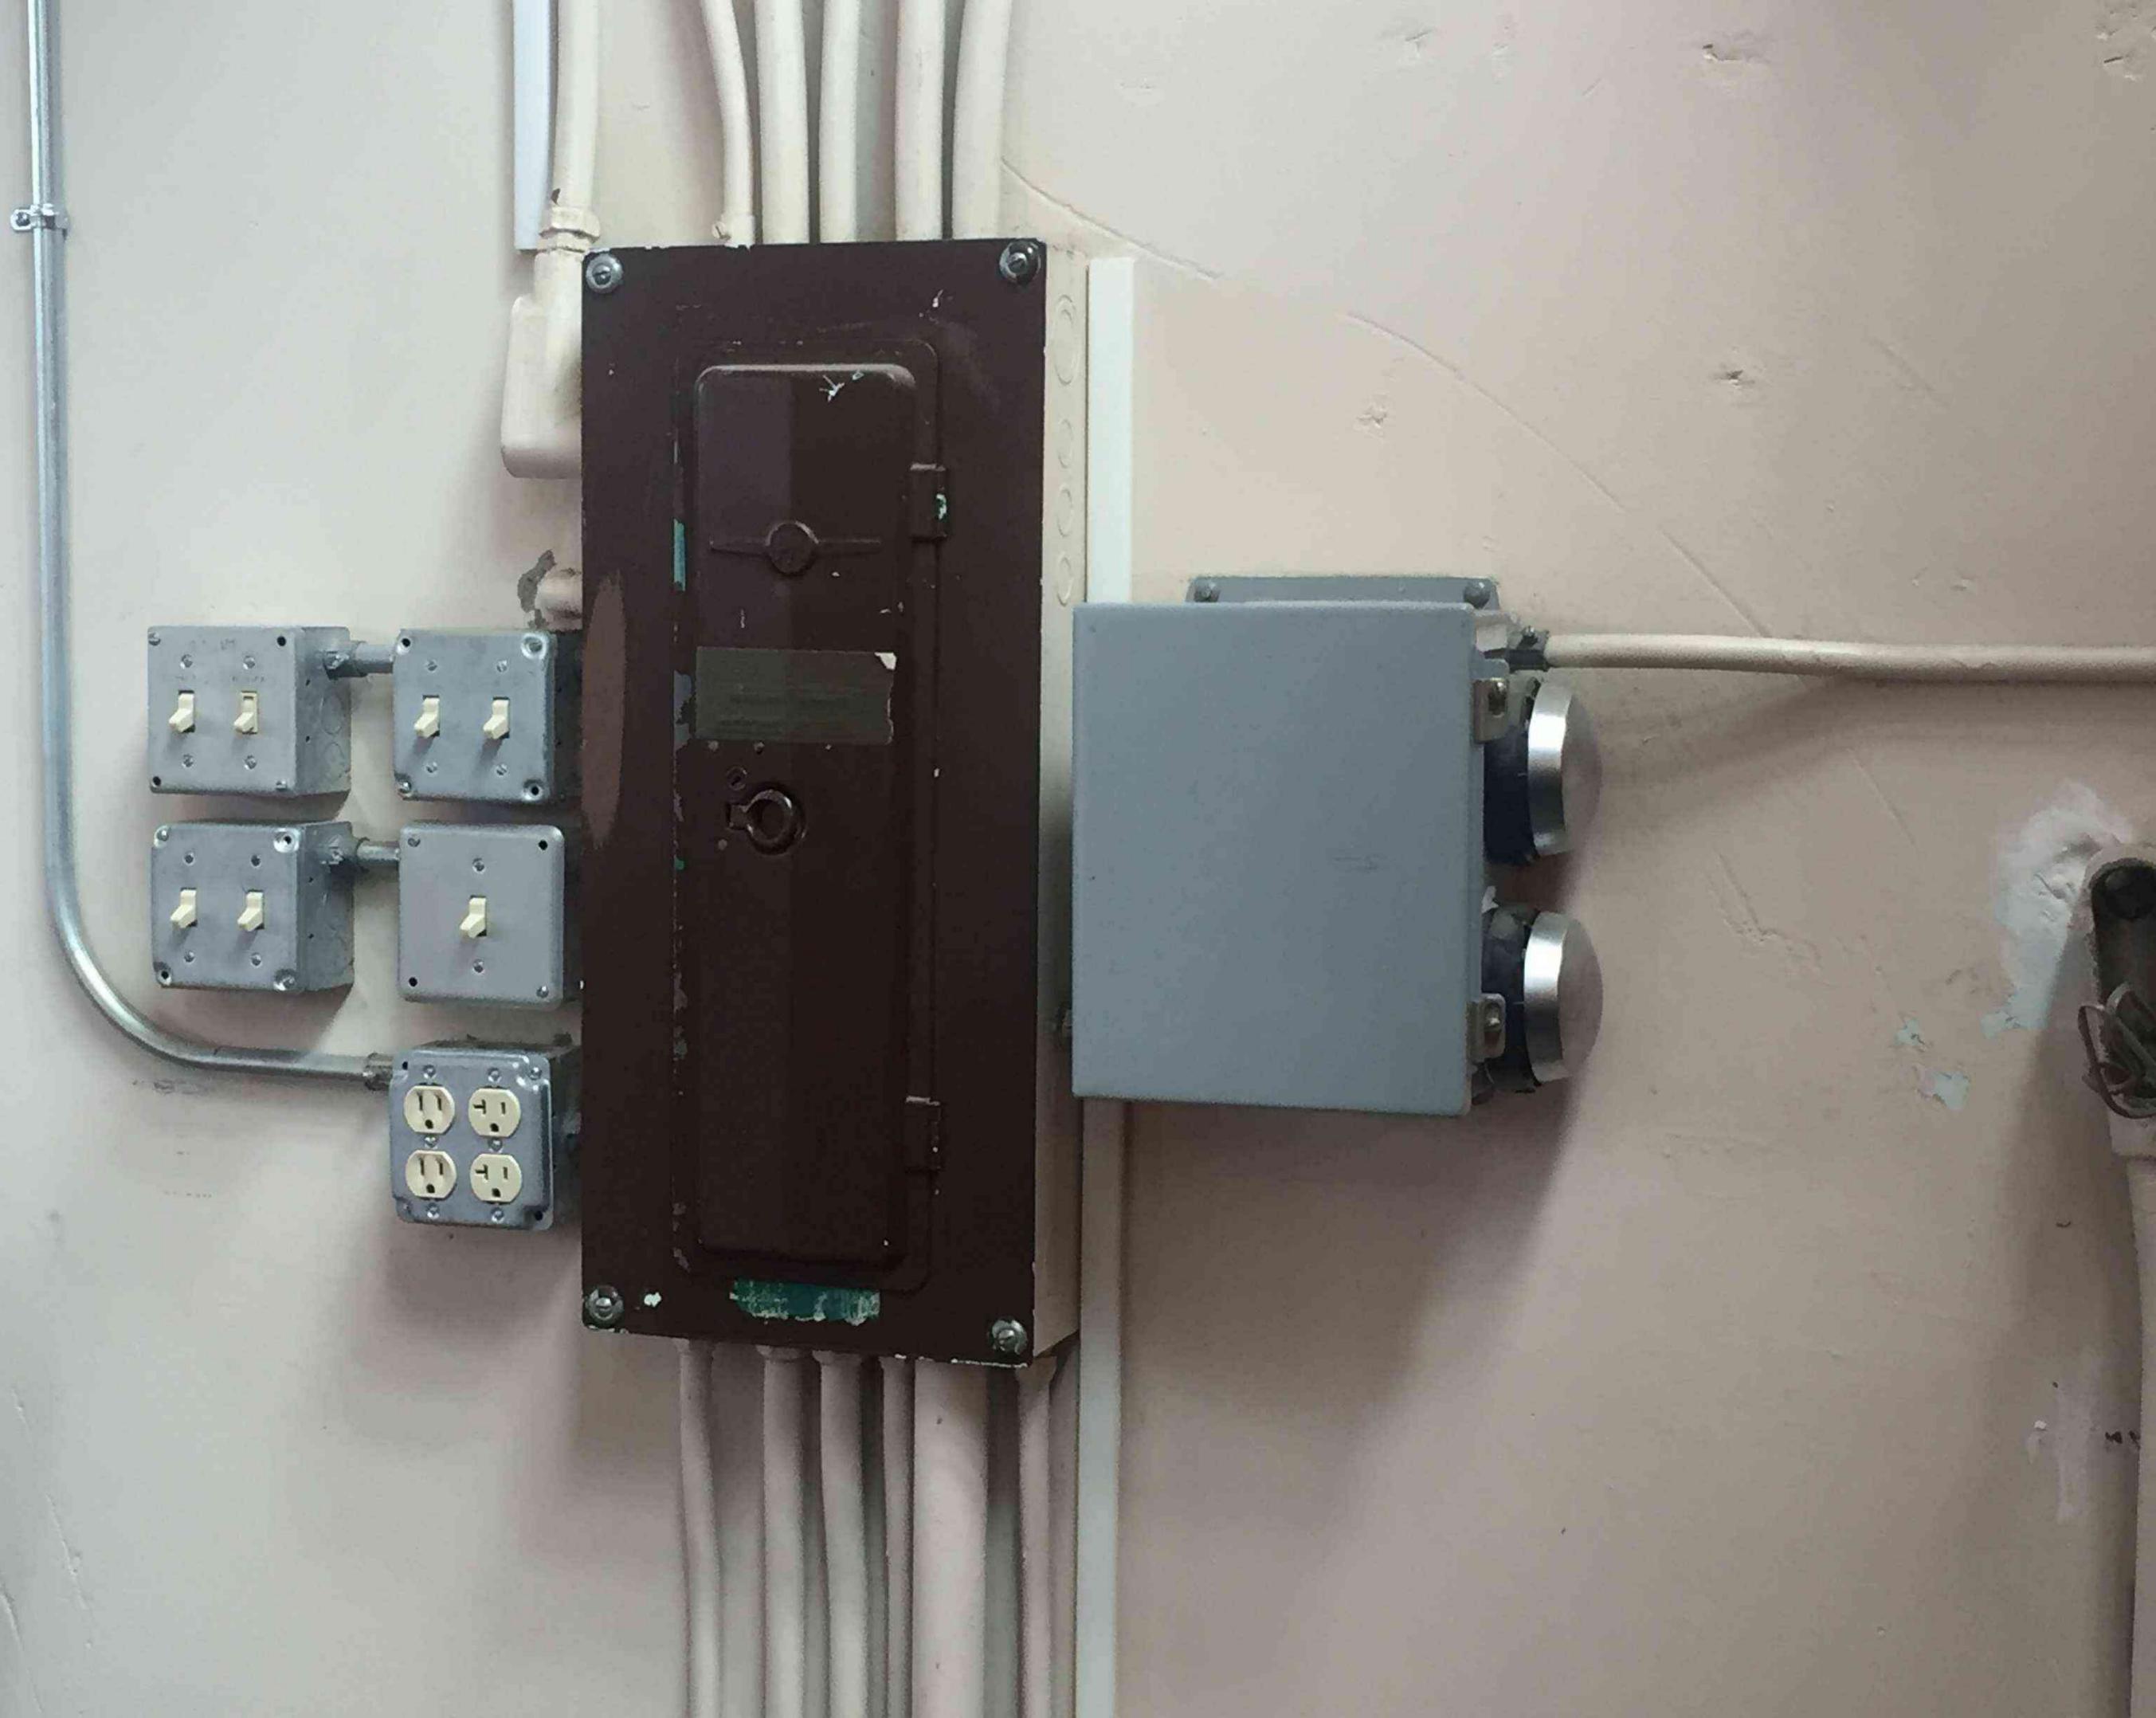
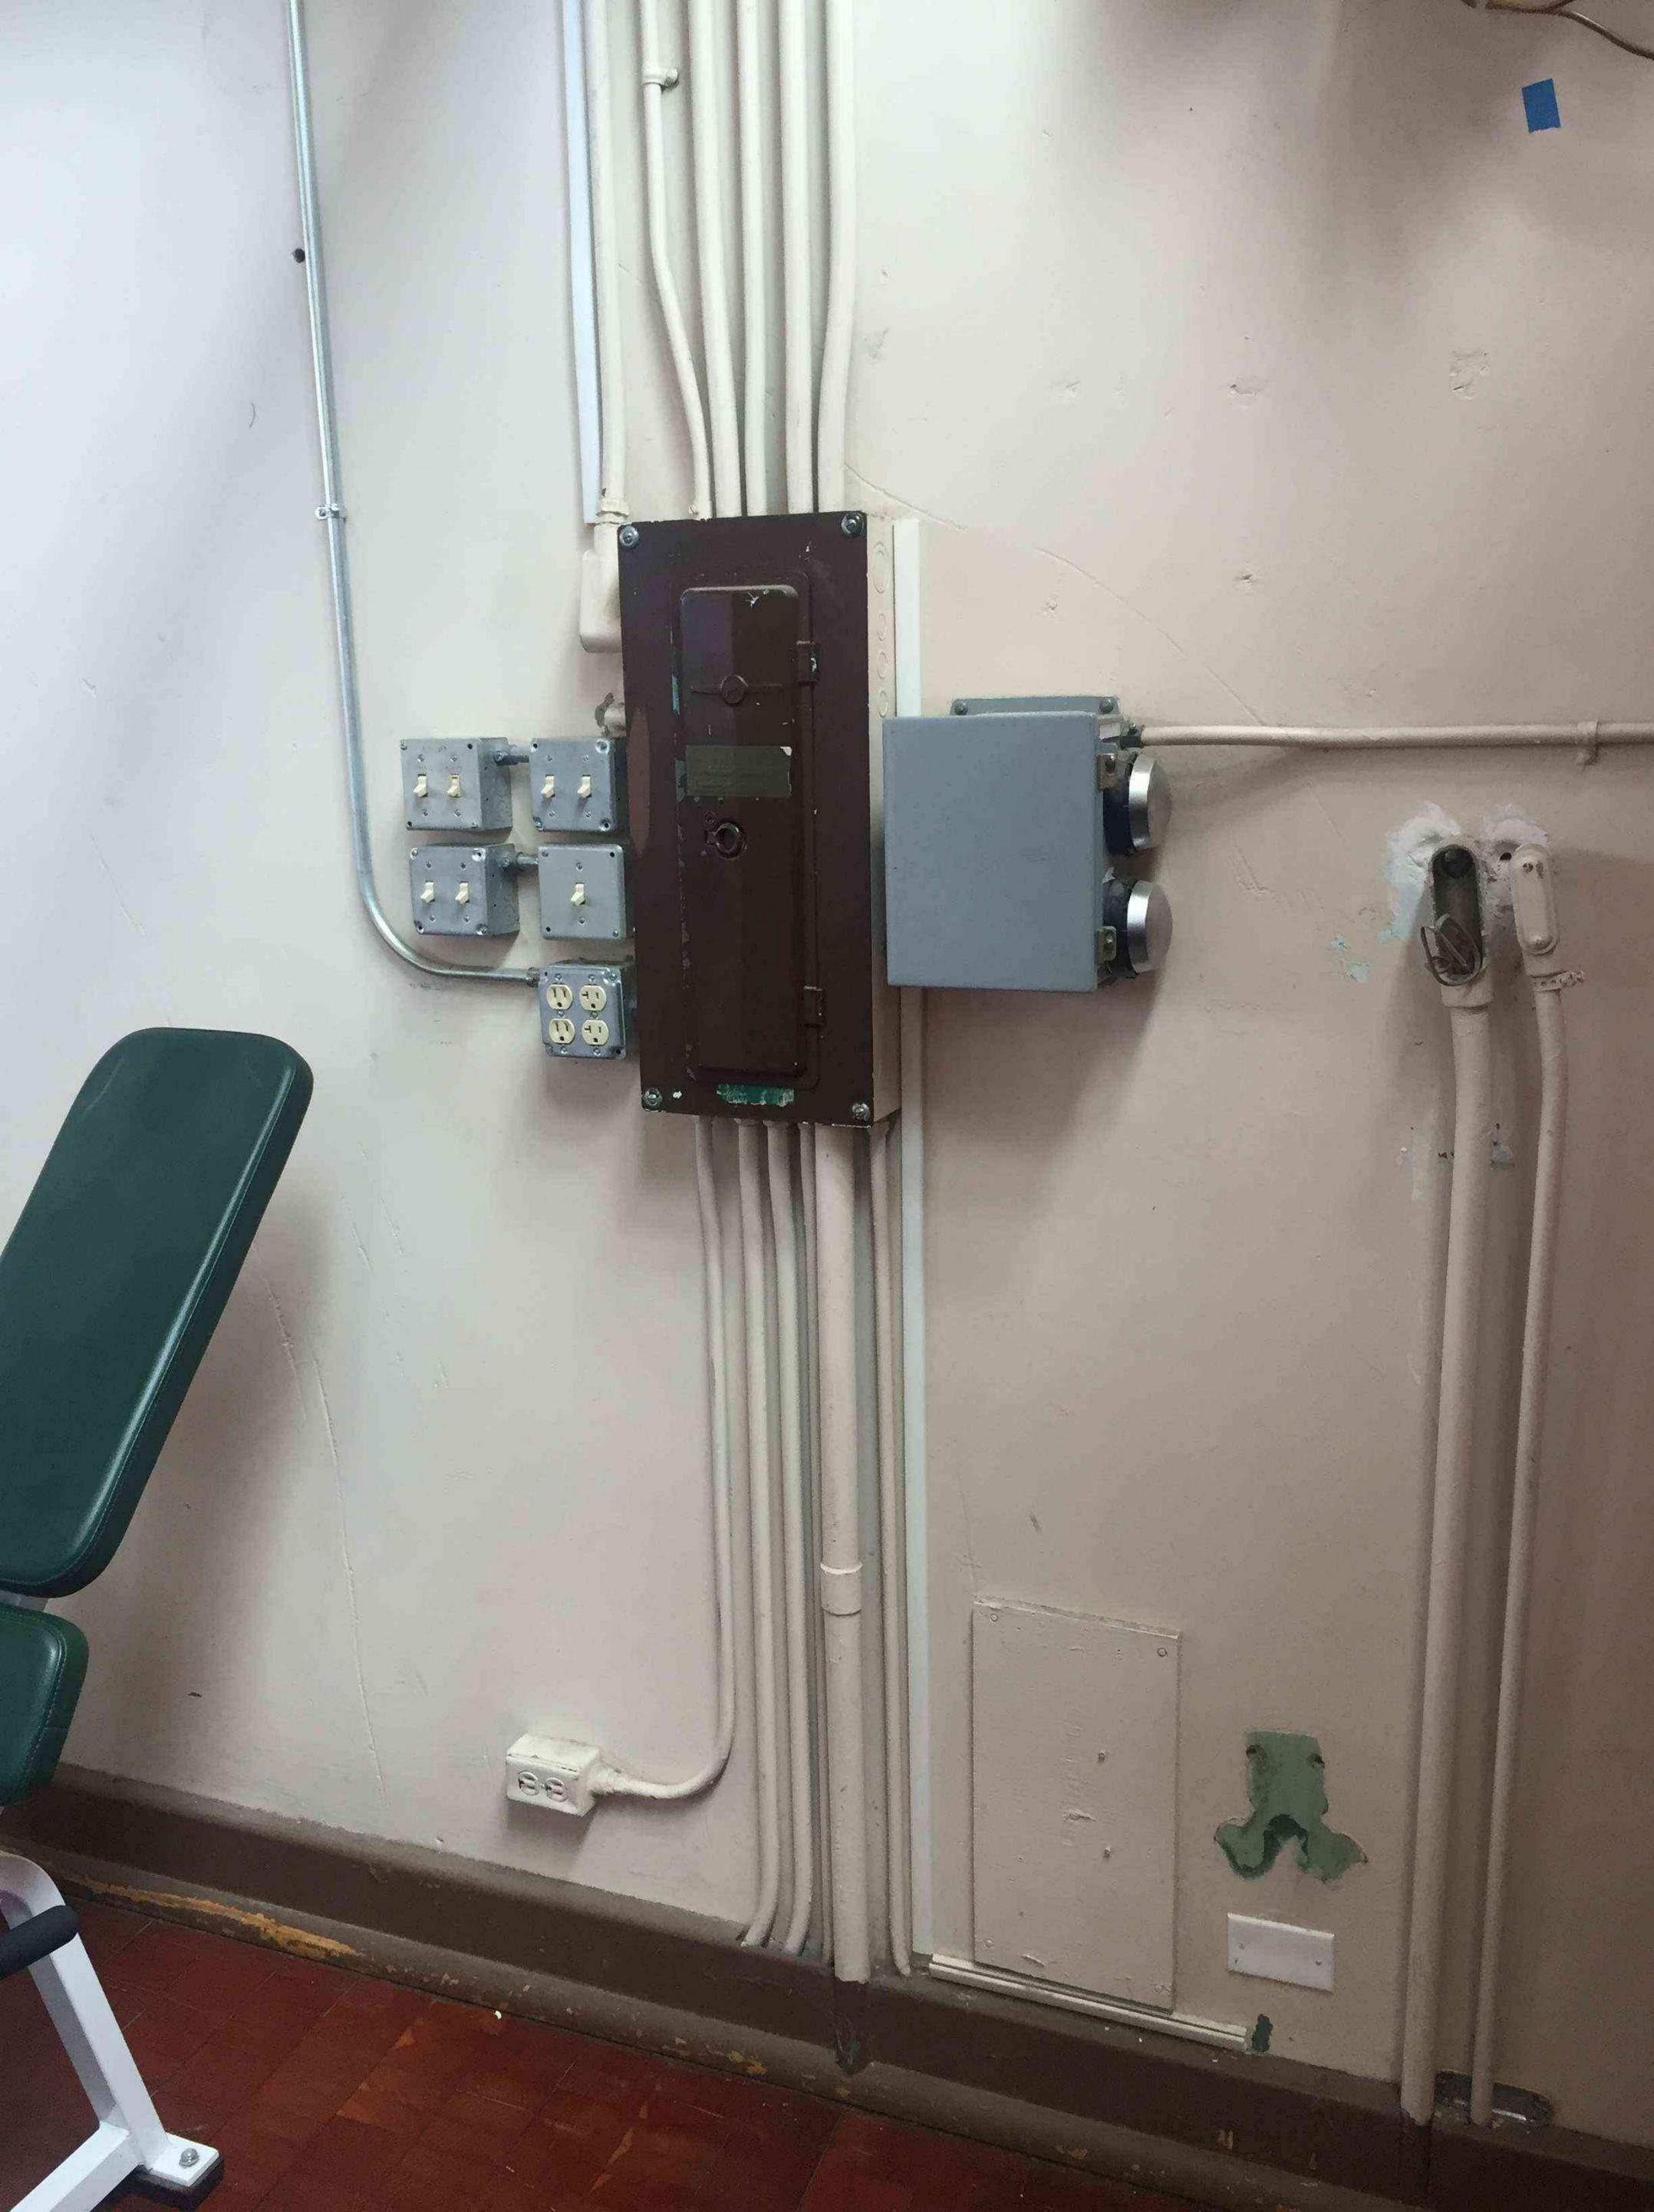
1.5	Electrical	Remove existing Panel 'B' located in the Assembly area. Provide replacement panel at same location: 120/240v, 100A, 30 circuit. Provide with circuit breakers to match existing ratings. Modify existing feeder conduit and conductors as required to accommodate new panel. Modify existing branch circuit conduit and conductors as required to accommodate new panel. Existing switches and receptacles adjacent to panel are to be modified as required. Contractor has the option to utilize existing panel tub as a junction box if code allows. See attached photos of existing panel.
