CAMP MURRAY – BUILDING 20
VAV TERMINAL UNIT REPLACEMENT
2023-619

ADDENDUM NO. 2

Subject: Hazardous Building Materials Consulting Services
Project 24-016
Camp Murray Building 20 VAV Terminal Replacement
Camp Murray Washington 98430
Med-Tox Northwest Project No. 9195.1

Hazardous Building Materials Survey— Project 24-106
Camp Murray Building 20 VAV Terminal Replacement

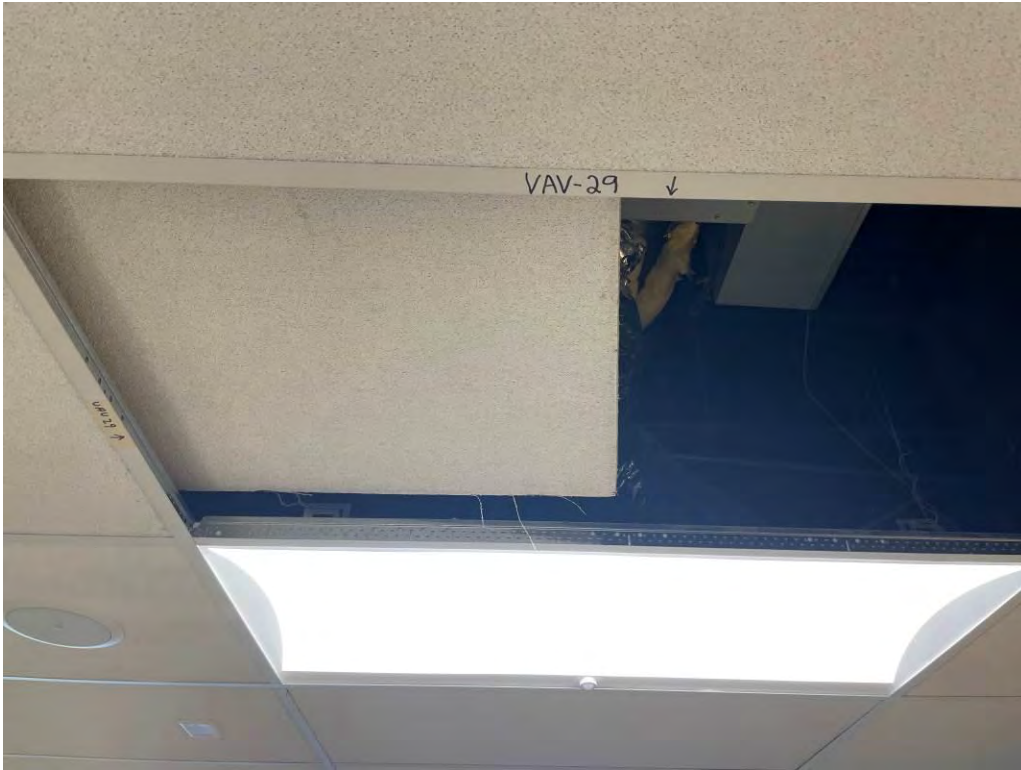
Photo 1: Typical VAV box locations were identified on the suspended ceiling t-grid. The ACT is negative for asbestos.

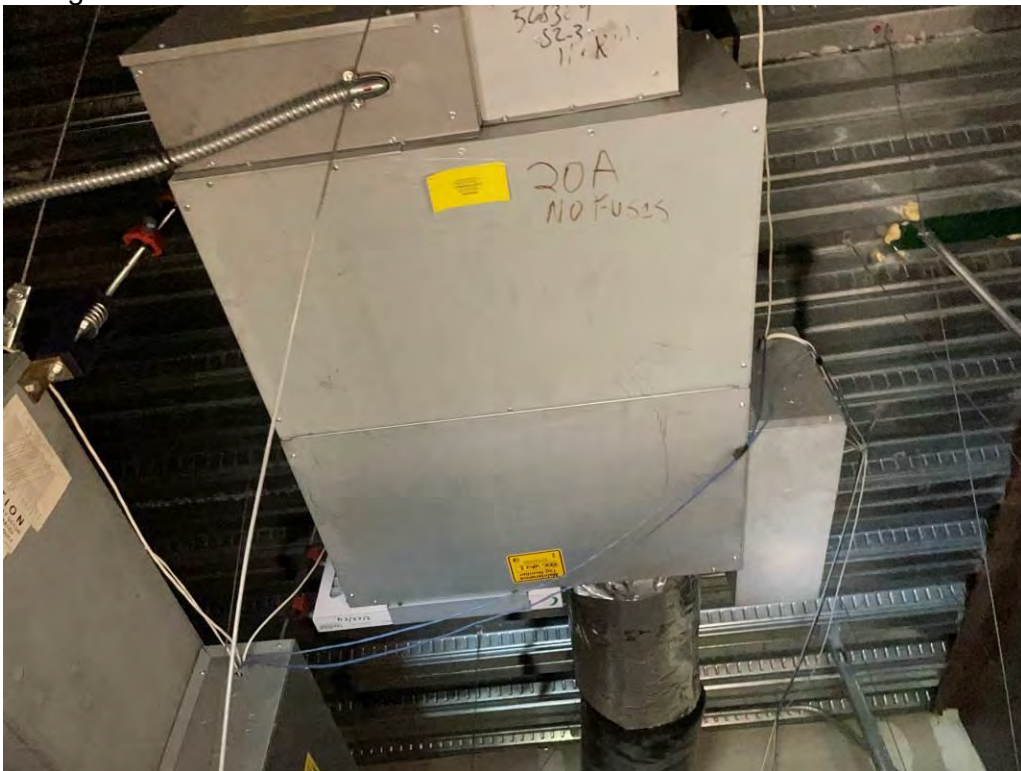
Photo 2: Typical VAV box observed.

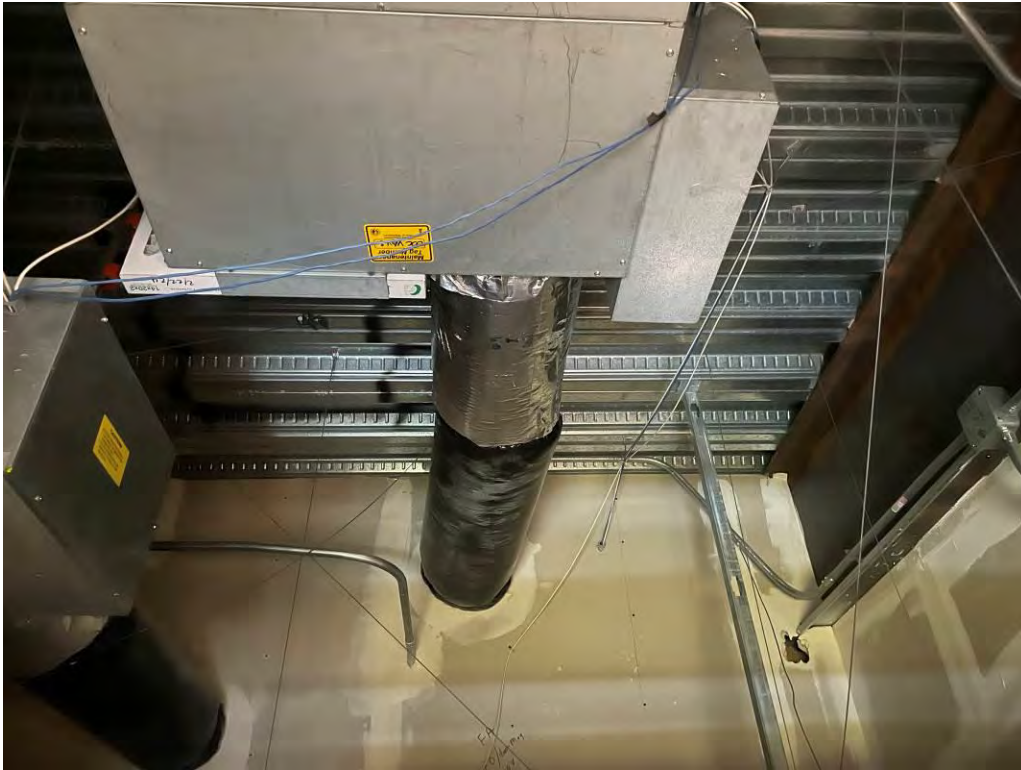
There was no asbestos containing materials (materials containing greater than 1% asbestos) identified in the survey activities completed by MTNW in the project area of Building 20. However, there was an un-textured GWB system that was determined to contain less than 1% asbestos as a composite (GWB, joint compound, and tape). If this material is going to be impacted by the project, WRD 23.10, *Occupational Exposure to Asbestos* and 23.30 Asbestos Containing Joint Compound in Wallboard Systems should be followed.

Photo 3: Non asbestos containing duct insulation and un-textured GWB system that is less than 1% asbestos when composited (GWB, joint compound, tape).

The material identified in **Table 3** was found to contain 1% or less Chrysotile asbestos. Materials with asbestos content 1% or less will require special handling during removal and/or demolition as detailed in Washington Industrial Safety and Health Act (WISHA) Regional Directive (WRD) 23.10, *Occupational Exposure to Asbestos* and 23.30 Asbestos Containing Joint Compound in Wallboard Systems.

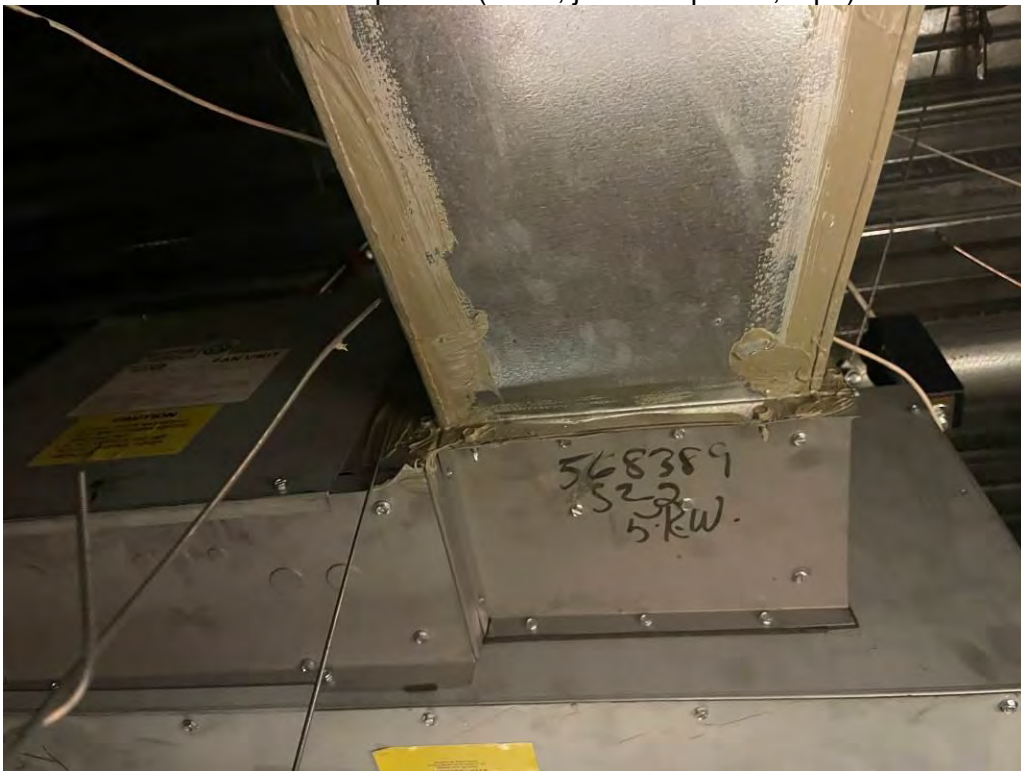
Photo 4: Non asbestos containing duct sealant.

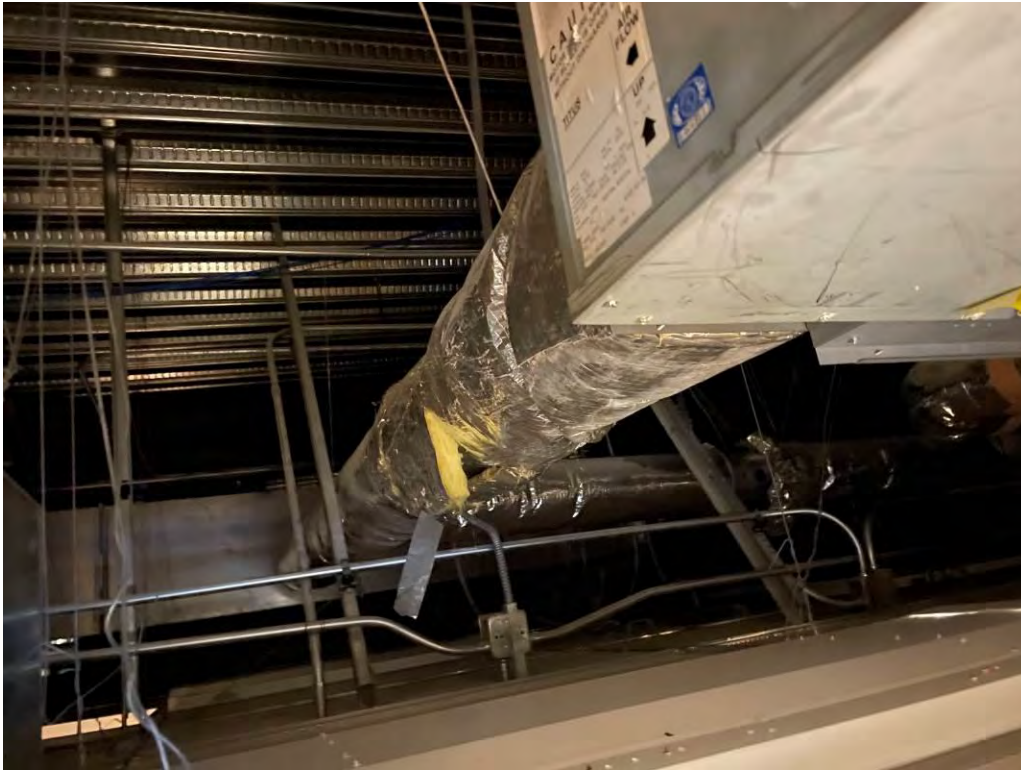
Photo 5: Bare metal pan decking and assorted hangars observed above the ceiling.

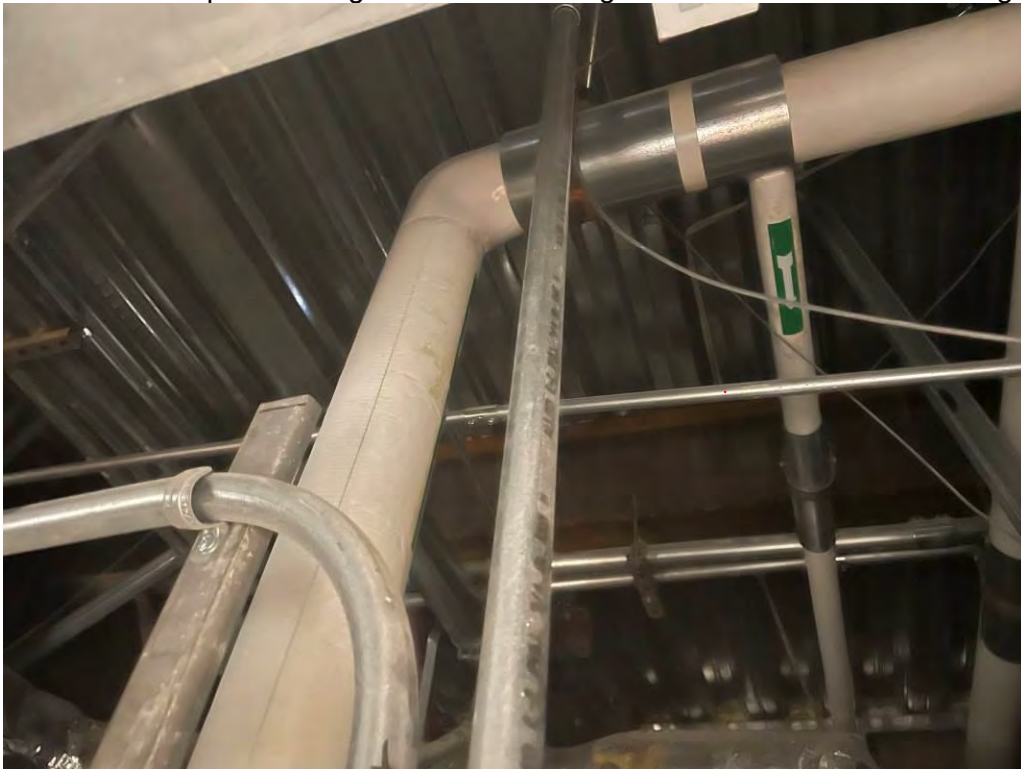
Photo 7: The pipes in the area are insulated with fiberglass with PVC fittings. They are not expected to be impacted by the project.
