**RE: Wetland Reconnaissance - TPN #51850001200, #09520003000, #09520004000, #09230019000, and #09230006000.**

## **Wetland Delineation Report Tumwater Readiness Center**

Kimmie St. SW  
Thurston County, Washington

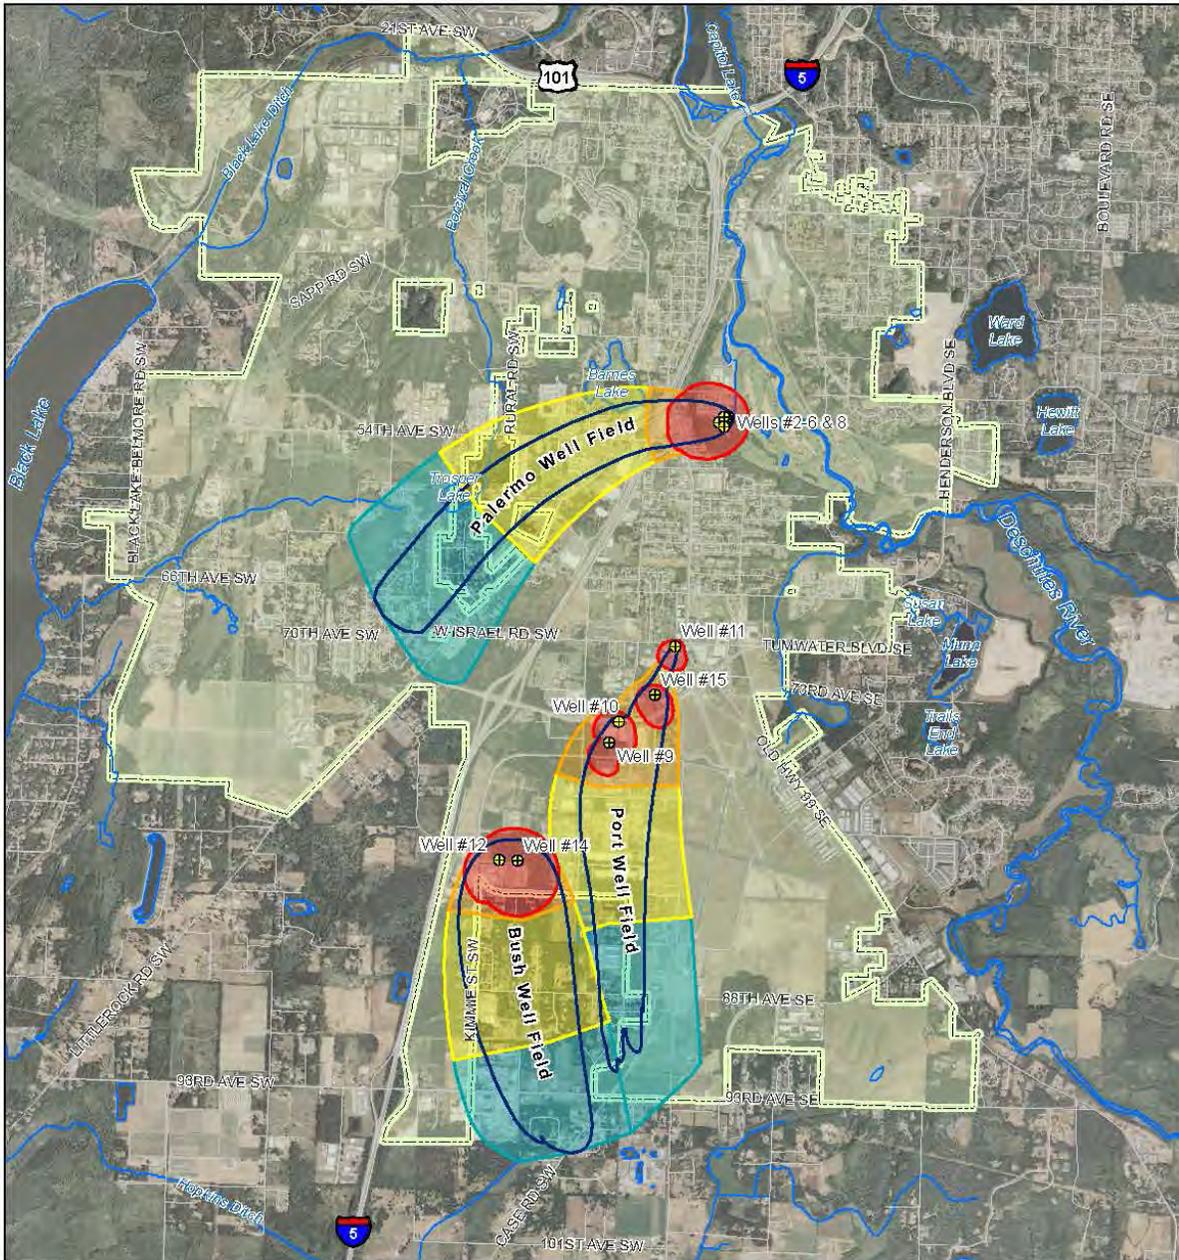
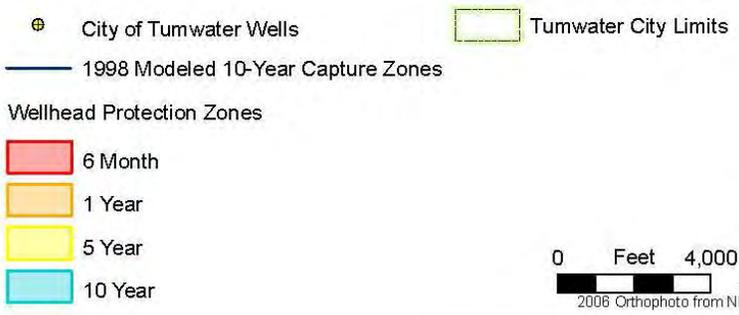
**Figure 1**  
Existing Wellhead Protection Areas for Currently Pumped Wells

Portions of the property are located in the 6-month, 1-year, and 5-year Time of Travel zone. For the new Readiness Center, this means that onsite fueling will likely not be allowed.

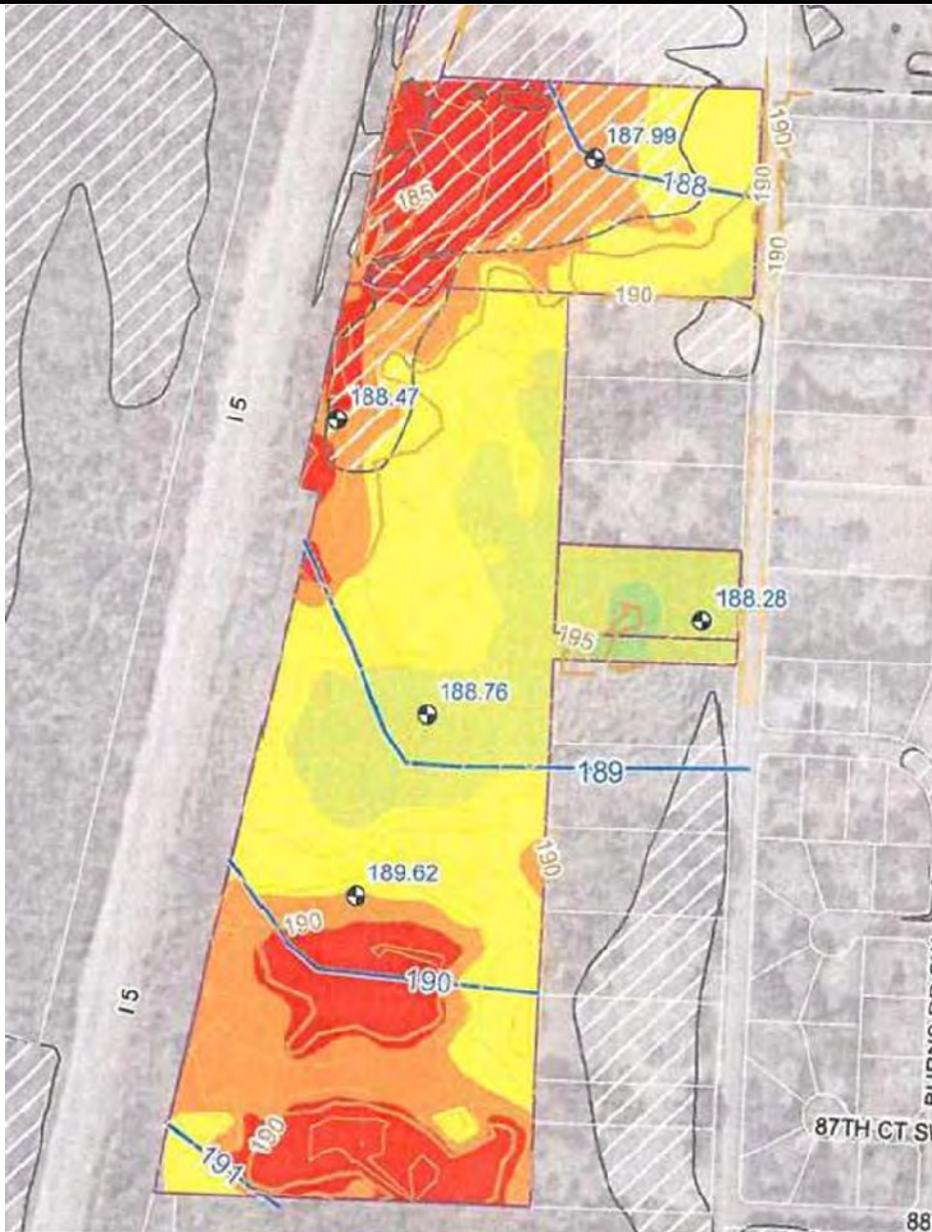
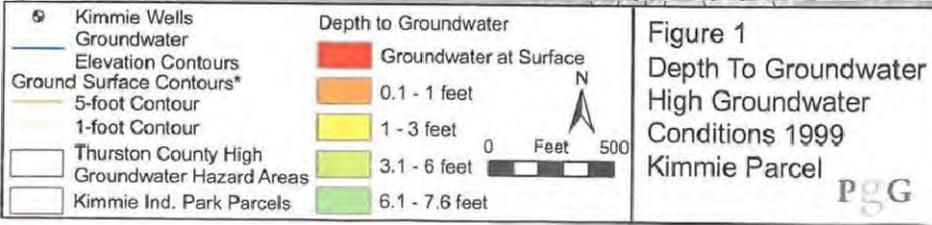
**FIGURE**  
**4**

**1999 HIGH GROUNDWATER ELEVATIONS**  
**Washington Military Department**  
**Tumwater Readiness Center**  
Thurston County, WA

The regression analysis suggests the high groundwater elevation across the site ranges from elevation 191 in the southwest corner to elevation 188 in the northeast corner. The ground surface on the parcel, based on 2-foot contour intervals, ranges from a high of 194 in the west-central portion of the site to 185 in the northwest corner of the site. During a high groundwater event, the groundwater may be at the surface in the northwest corner and at the south end of the property. The south end of the parcel is also encumbered with a wetland.

There is an area north of the PBS mapped boundary of Wetland B that is a possible third wetland and that is shown on the groundwater map as being flooded in 1999. The area is dominated by black cottonwood and is similar in many regards to Wetland B. During our site visit in May, we found this area inconclusive and determined that an additional site visit was needed to make a final assessment. We have identified the area on the delineation map (Figure 7) as needing further study. An additional site visit is highly recommended during the winter or early spring to verify status of this area and also to confirm the boundaries of Wetland A.

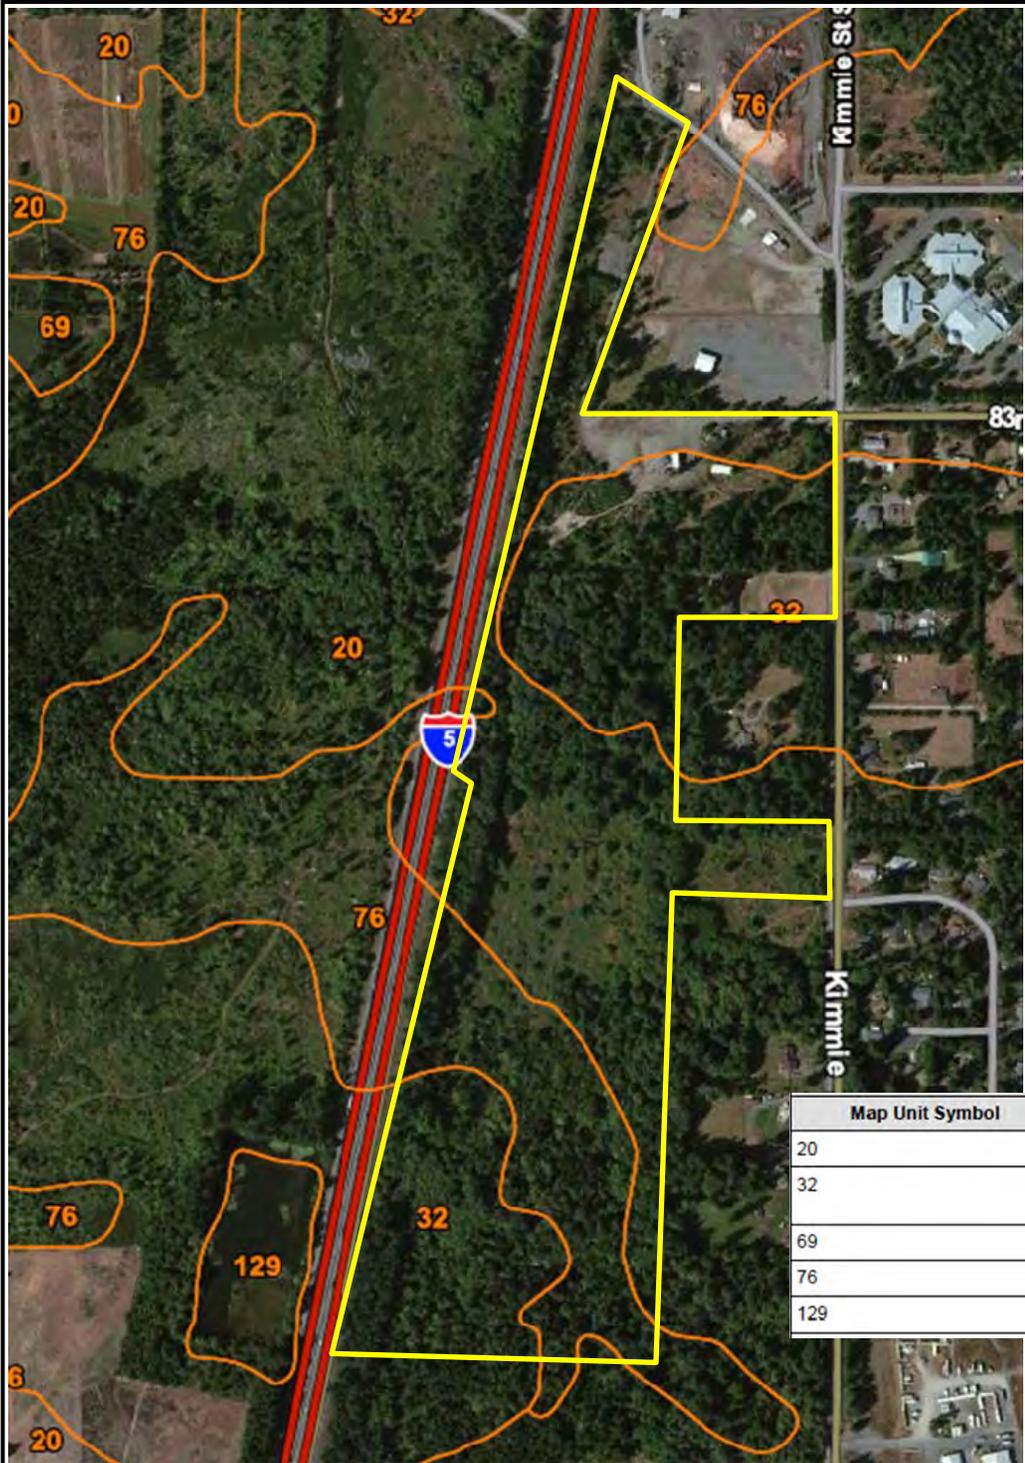
Project # 40683.001	<b>NRCS SOIL SURVEY</b> <b>Washington Military Department</b> <b>Tumwater Readiness Center</b> Thurston County, WA	<b>FIGURE</b> <b>5</b>
	Date: July, 2016

Map Unit Symbol	Map Unit Name
20	Cagey loamy sand
32	Everett very gravelly sandy loam, 0 to 8 percent slopes
69	Mukilteo muck
76	Norma silt loam
129	Water

Soils on the Property are mapped primarily as Cagey loamy sand and Everett very gravelly sandy loam. The northern and southern sections also contain areas mapped as Norma silt loam. Cagey silt loam and Everett very gravelly sandy loam are not listed as hydric on the Hydric Soils List for Thurston County, Washington<sup>ii</sup>. Norma silt loam is listed as hydric however, which is typically found in depressional areas. The area mapped as Norma silt loam corresponds to the area of the identified wetland.

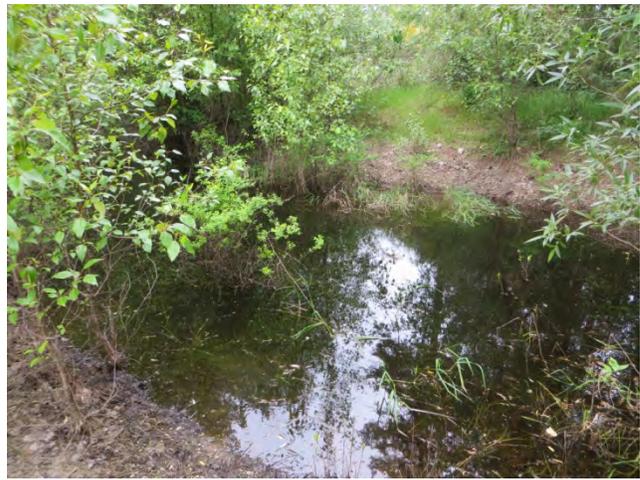
Photo 2. Wetland A excavated pond

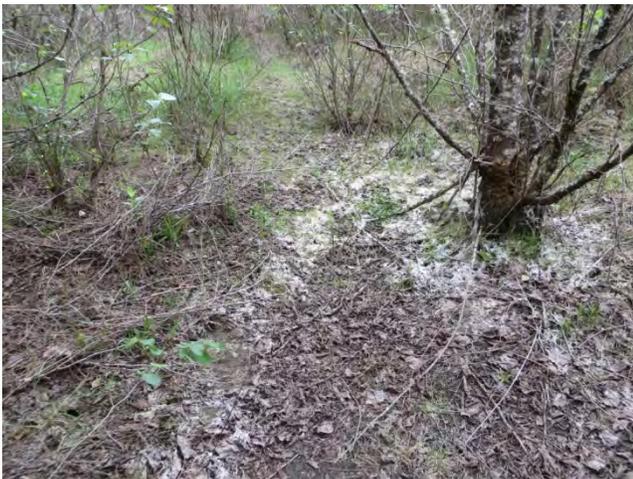
Photo 3. Wetland A swale leading into excavated pond showing evidence of recent ponding

Remarks: Shallow swale upslope from excavated pond with standing water. Surface elevation in plot is about 12 inches higher than standing water in pond. Entire area was graded about 15 years ago. Existing condition is new normal.

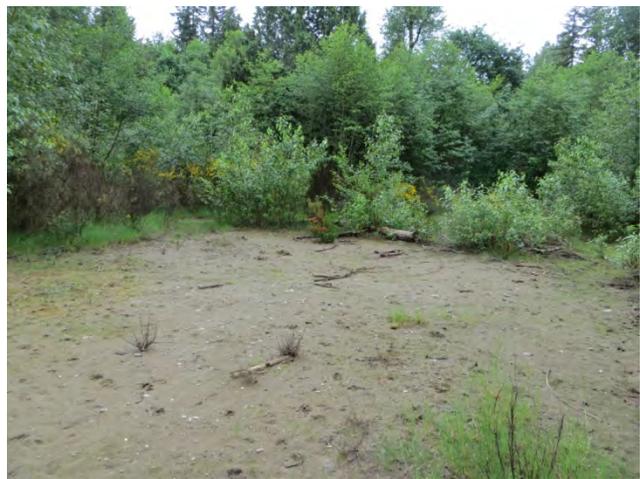
Photo 4. Area to east of Wetland A that looks like it may have recently flooded.

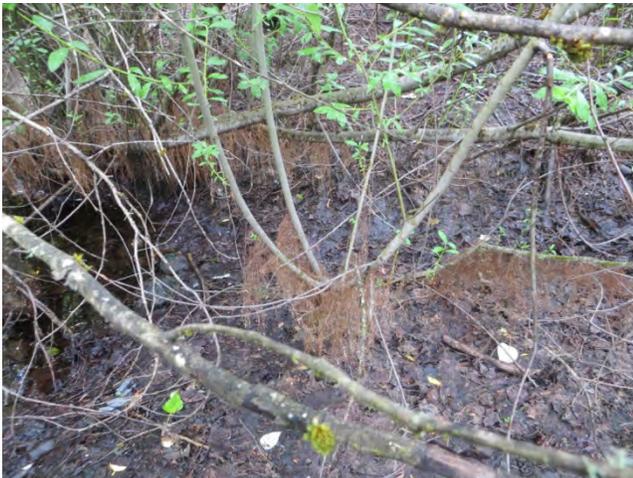
Photo 5. Adventitious roots on willows at edges of Wetland A excavated pond

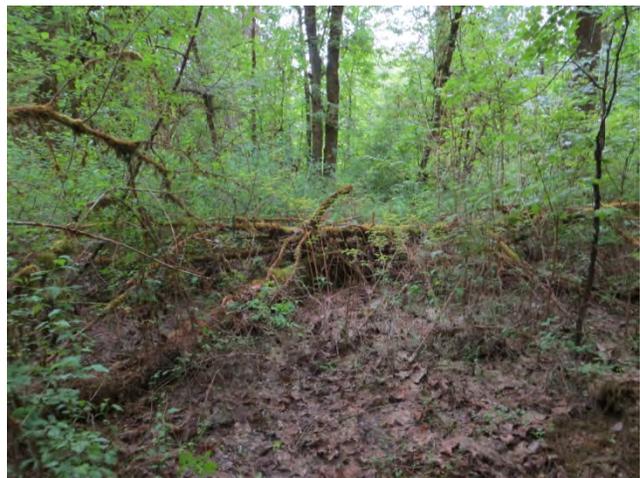
Photo 10. Evidence of recent ponding in Wetland B

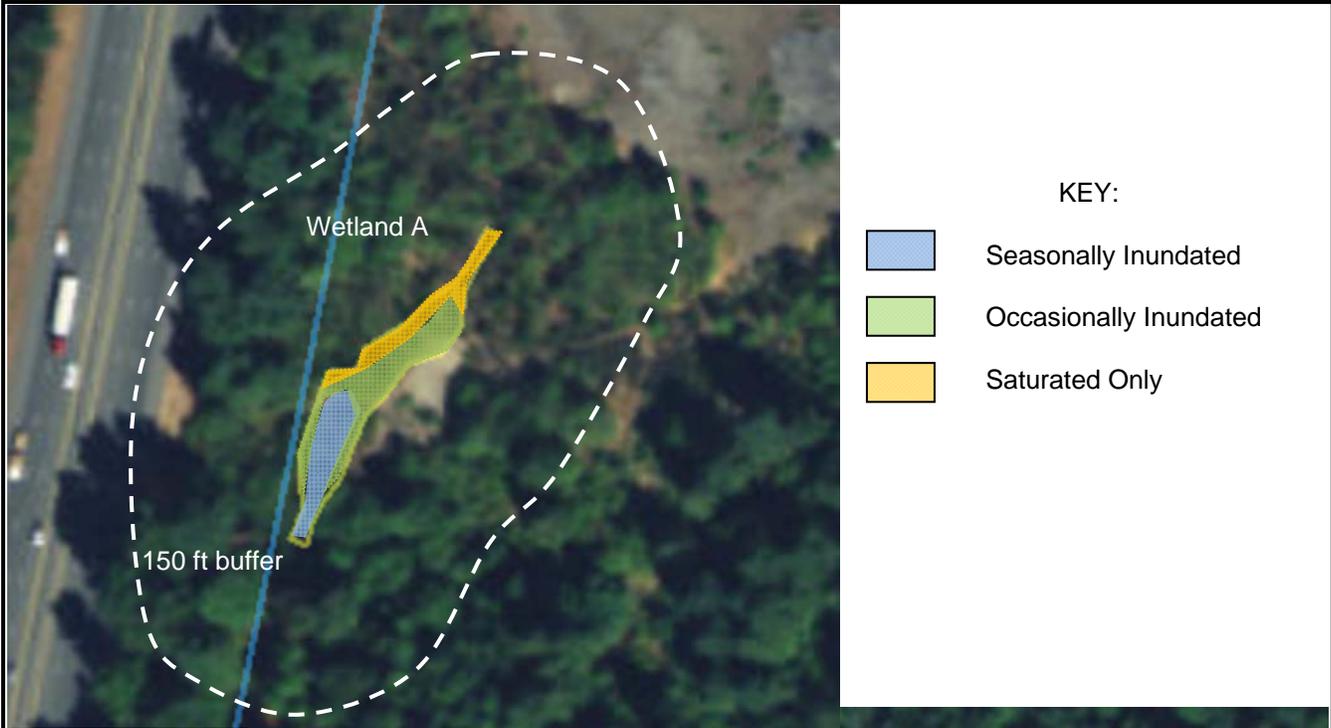
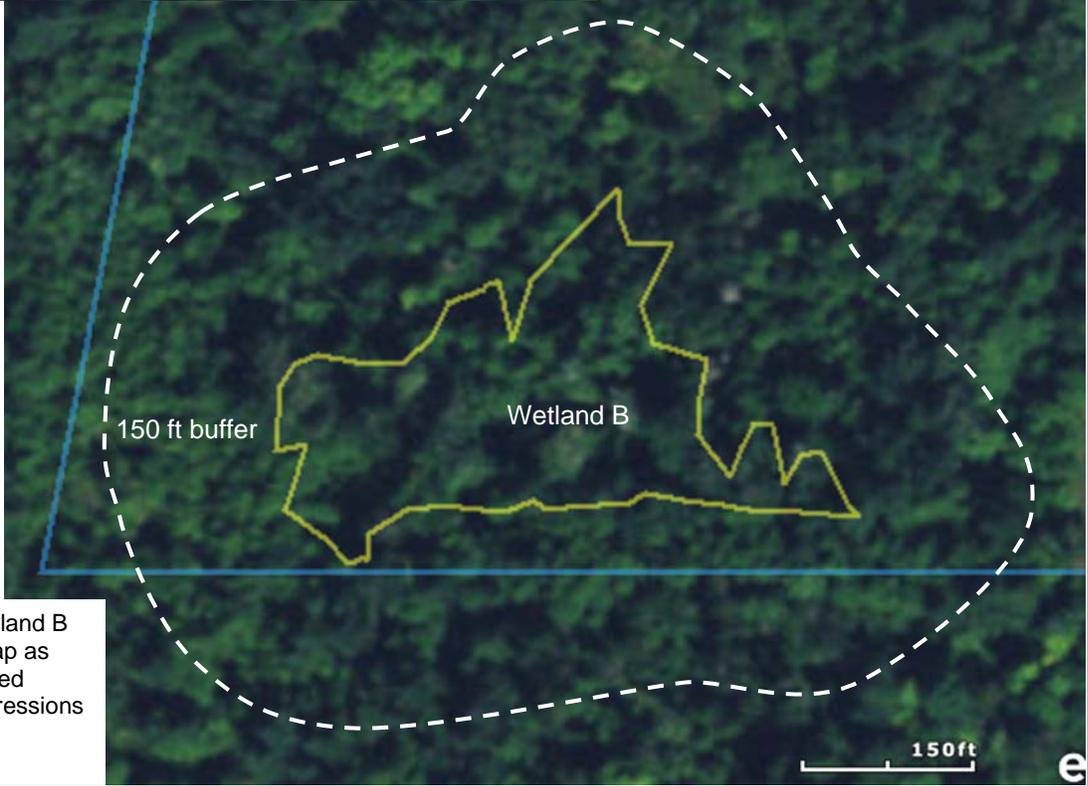
<p>Project # 40683.001 Date: July 2016</p>	<p><b>Wetland Rating – Hydroperiods and 150' Buffer</b> <b>Washington Military: Tumwater Readiness Center</b> Tumwater, WA</p>	<p><b>Rating</b> <b>Figure</b> <b>2</b></p>
--	--	--	---

Hydroperiods in Wetland B are impossible to map as they are a complicated mosaic of small depressions and interconnecting channels

There are some questions in the rating system that are difficult to answer based on a single field visit. The distribution of hydroperiods and extent of seasonal ponding can be particularly difficult. At the Tumwater Readiness Center site, seasonal ponding in depressional wetlands likely extends from late November or December until late March or April but can be highly variable depending on the year. At our visit in late May ponding was observed in the excavated portion of one wetland but nowhere else. Since this was past the usual seasonal ponding window we have assumed that greater ponding would occur during the winter and early spring. To be conservative, we have estimated that slightly more than 1/2 of the wetlands stays ponded for more than 2 months.

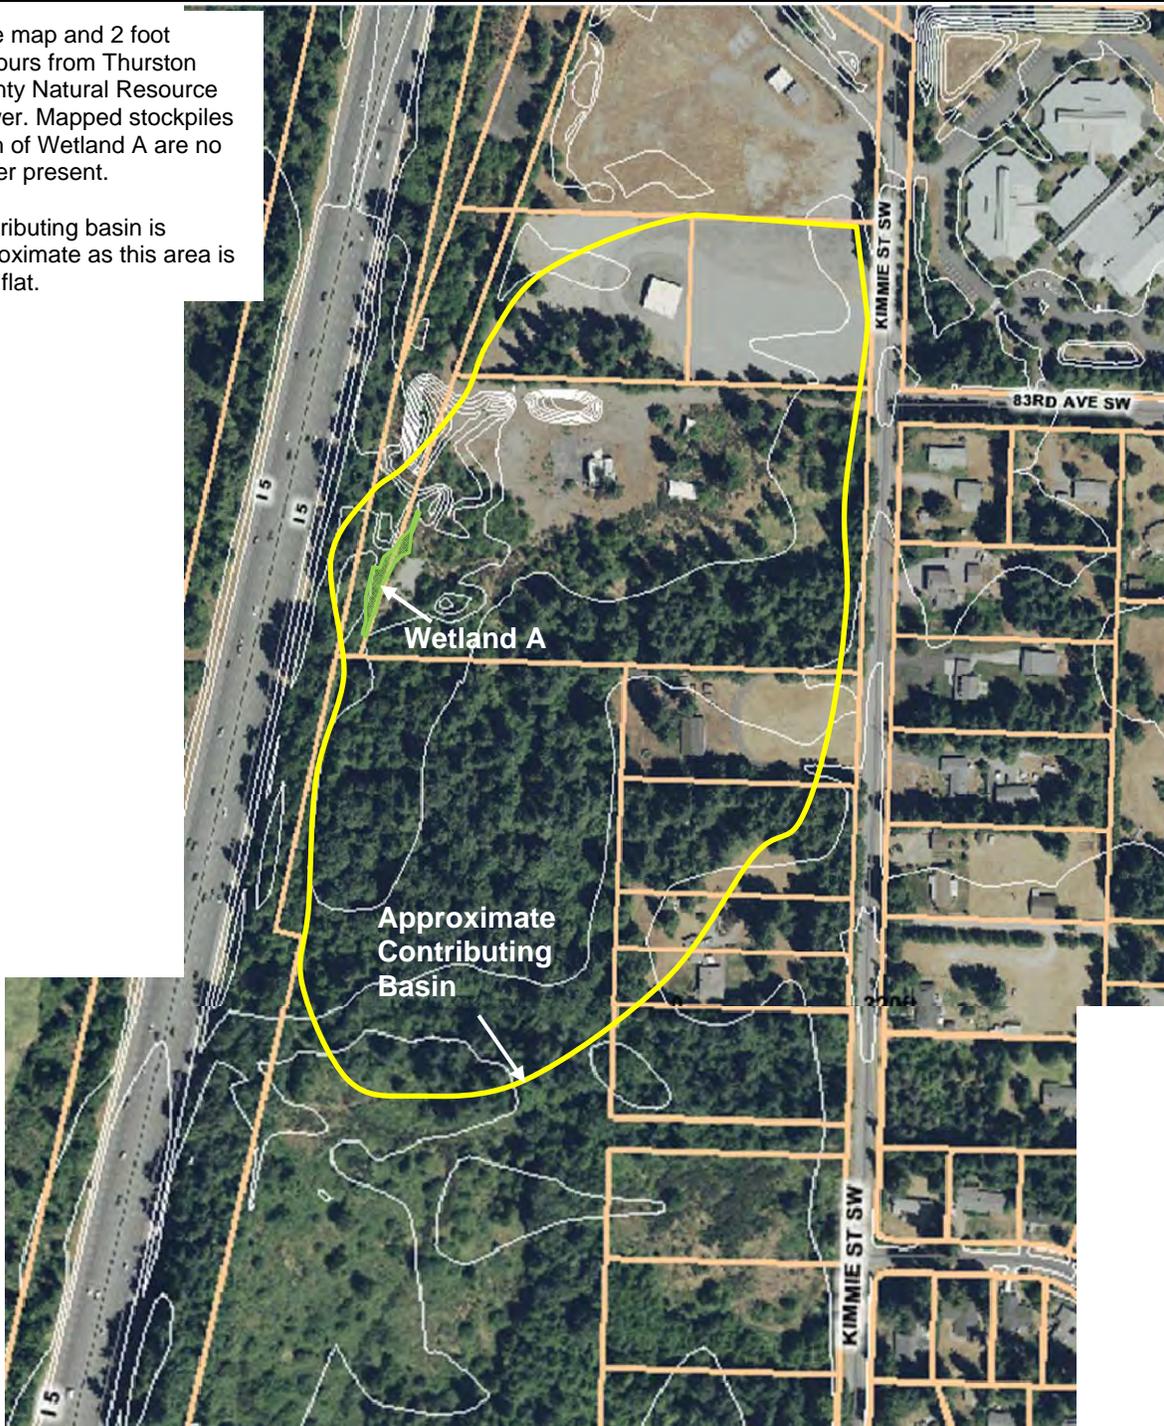
**Wetland Rating – Contributing Basin Wetland A**  
**Washington Military: Tumwater Readiness Center**  
Tumwater, WA

Contributing basin is approximate as this area is very flat.

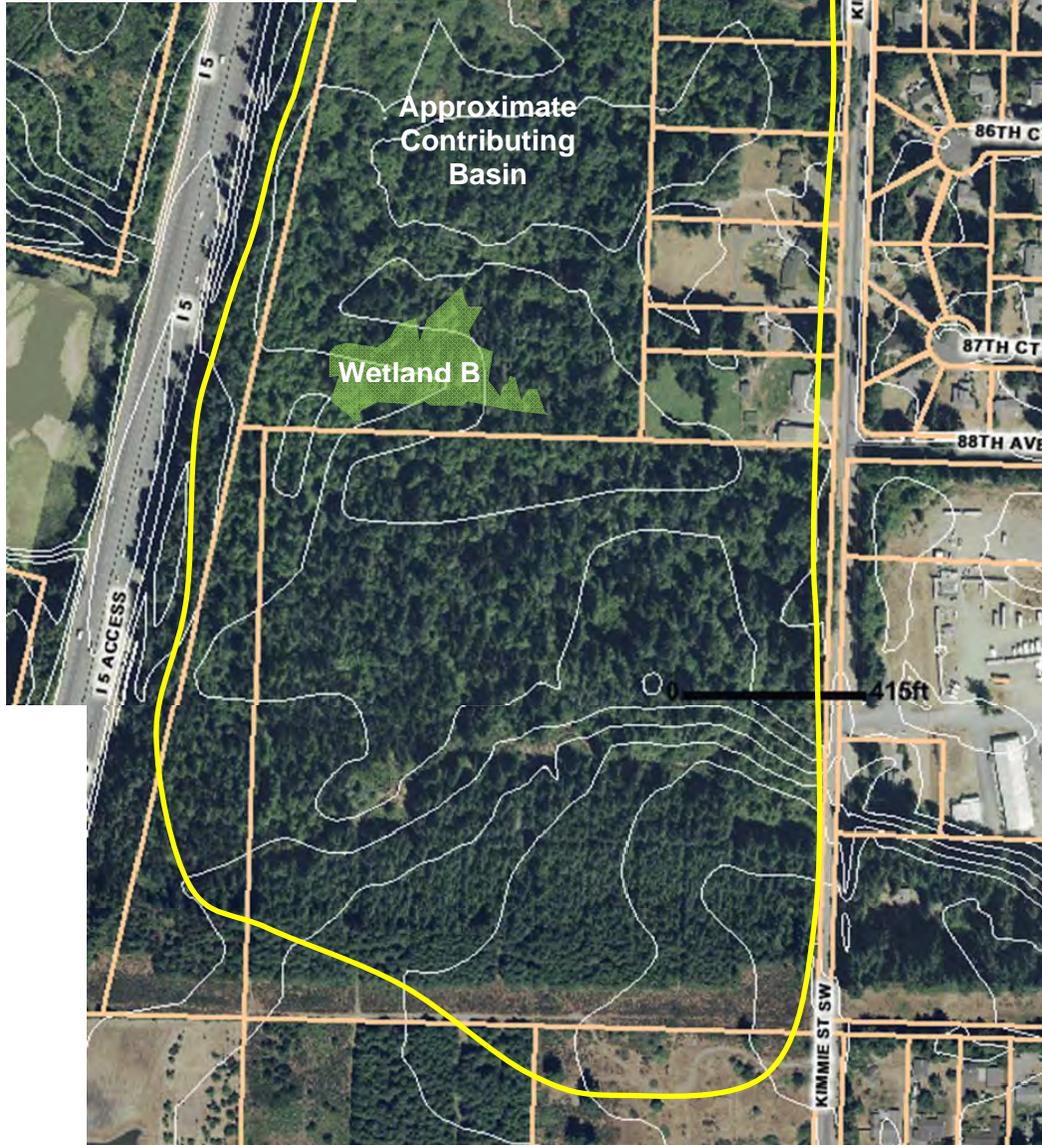
**Wetland Rating – Contributing Basin Wetland B**  
**Washington Military: Tumwater Readiness Center**  
Tumwater, WA

Contributing basin is approximate as site is very flat.

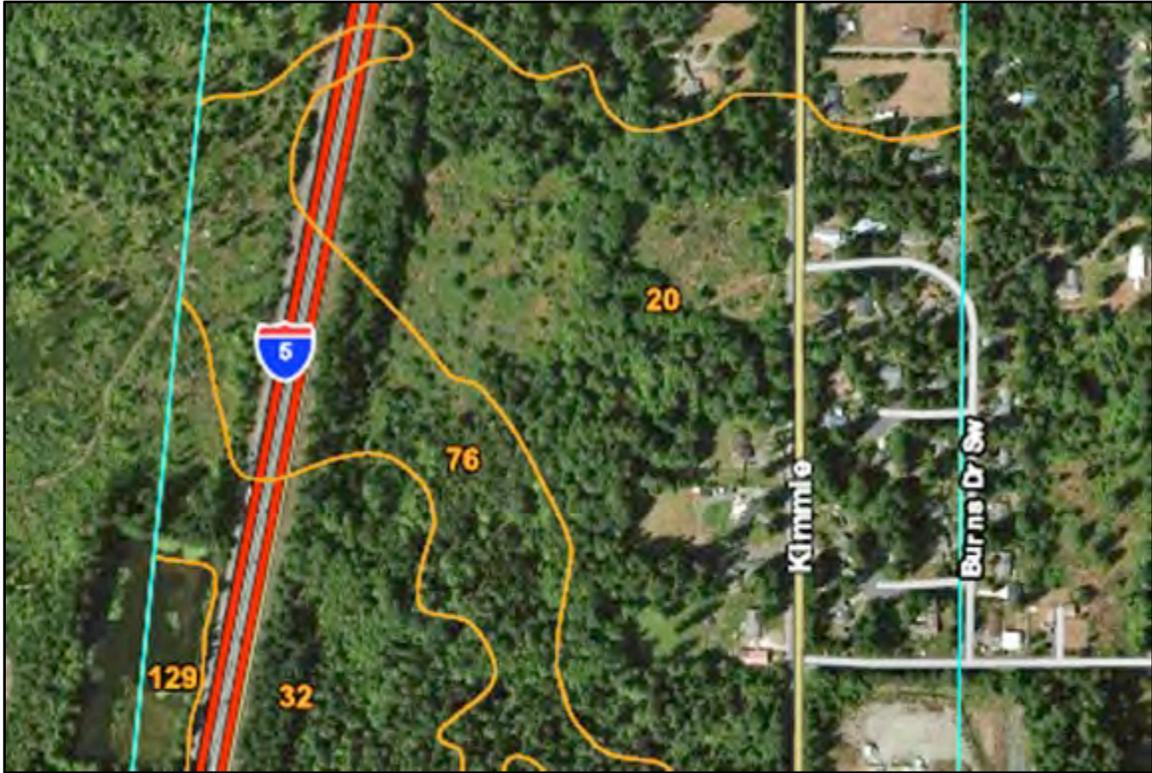
Figure 9. Portion of air photo annotated with soil map (source: USDA).  
Key: Norma silt loam (76); Cagey loamy sand (20); Everett very gravelly sandy loam (32).

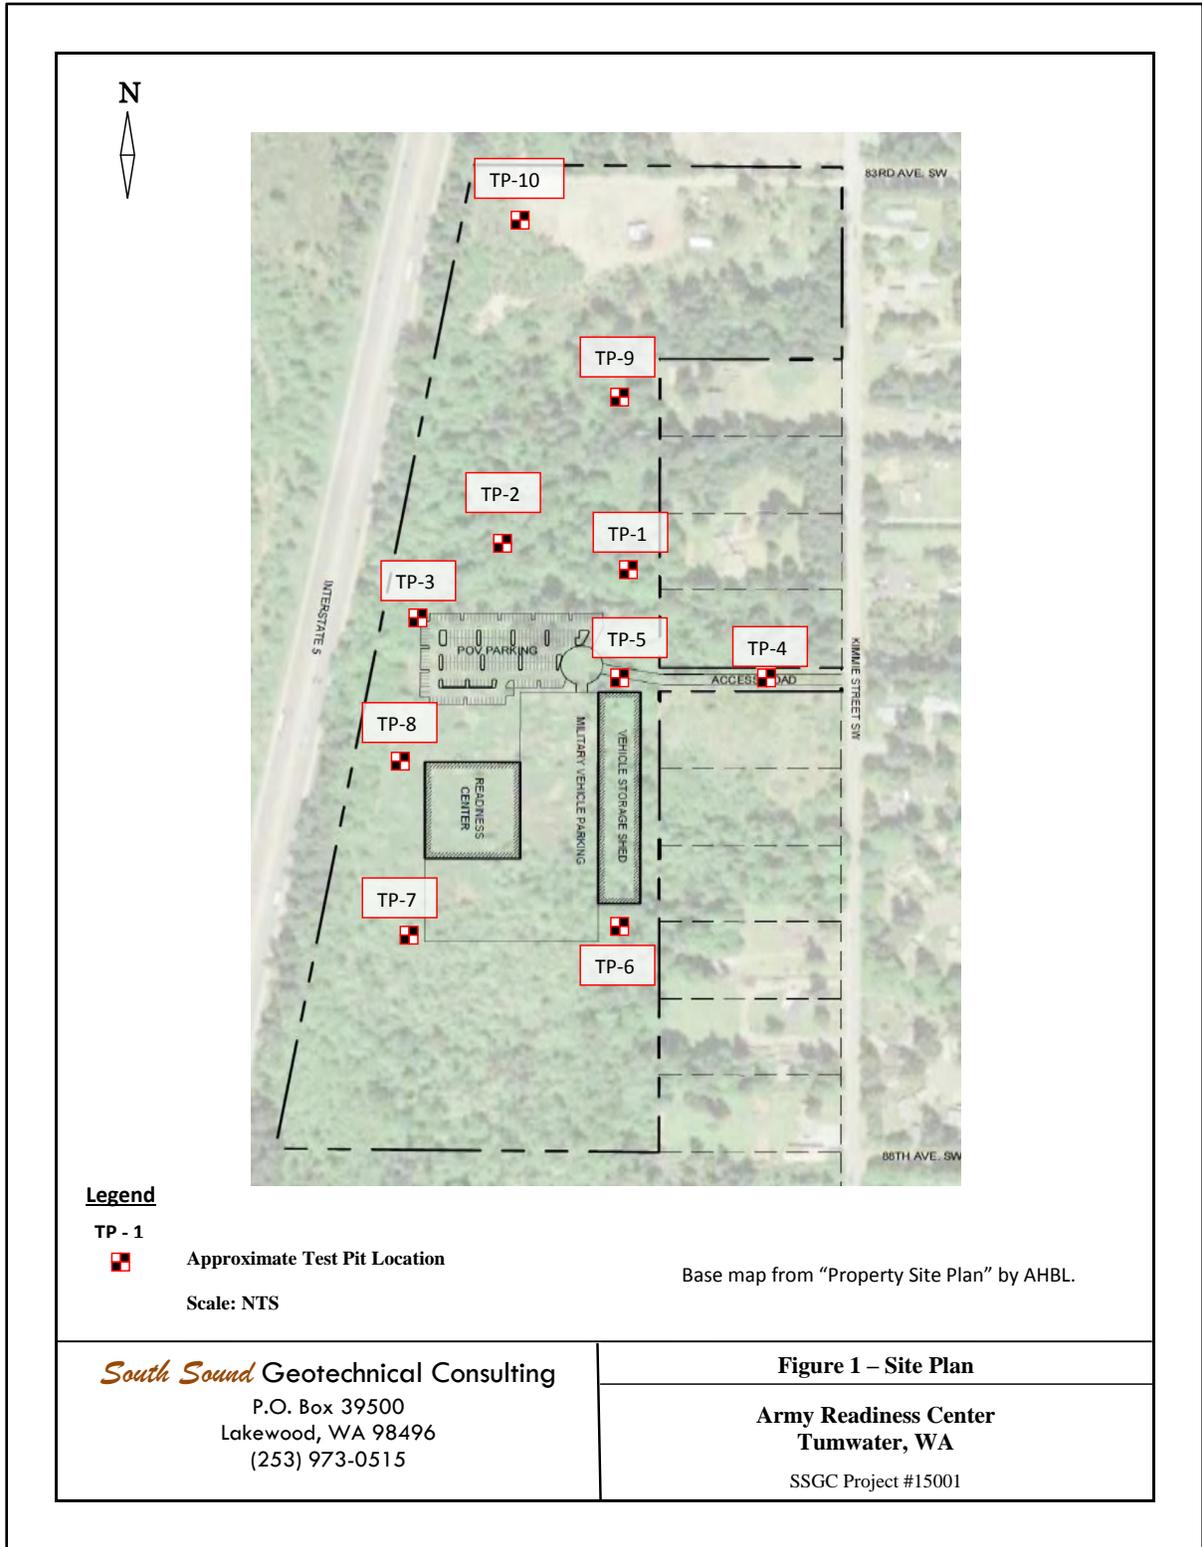
Figure 10. Map of geotechnical assay locations (South Sound Geotechnical Consulting 2015).

A preliminary geotechnical analysis was completed for the property by South Sound Geotechnical Consulting (SSGC), dated January 16, 2015. SSGC found that native soils consist of sand with variable silt. Coarser gravelly sand was observed below the top layer of sand in the northern portions of the site. The study concluded that most of the site is considered feasible for development from a geotechnical perspective. Groundwater was observed in two test pits at the time of excavation. Depth to groundwater was in the order of magnitude of 11 feet in the south-central portion and 7 feet in the most northerly test pit. See the enclosed geotechnical study for more detailed information.

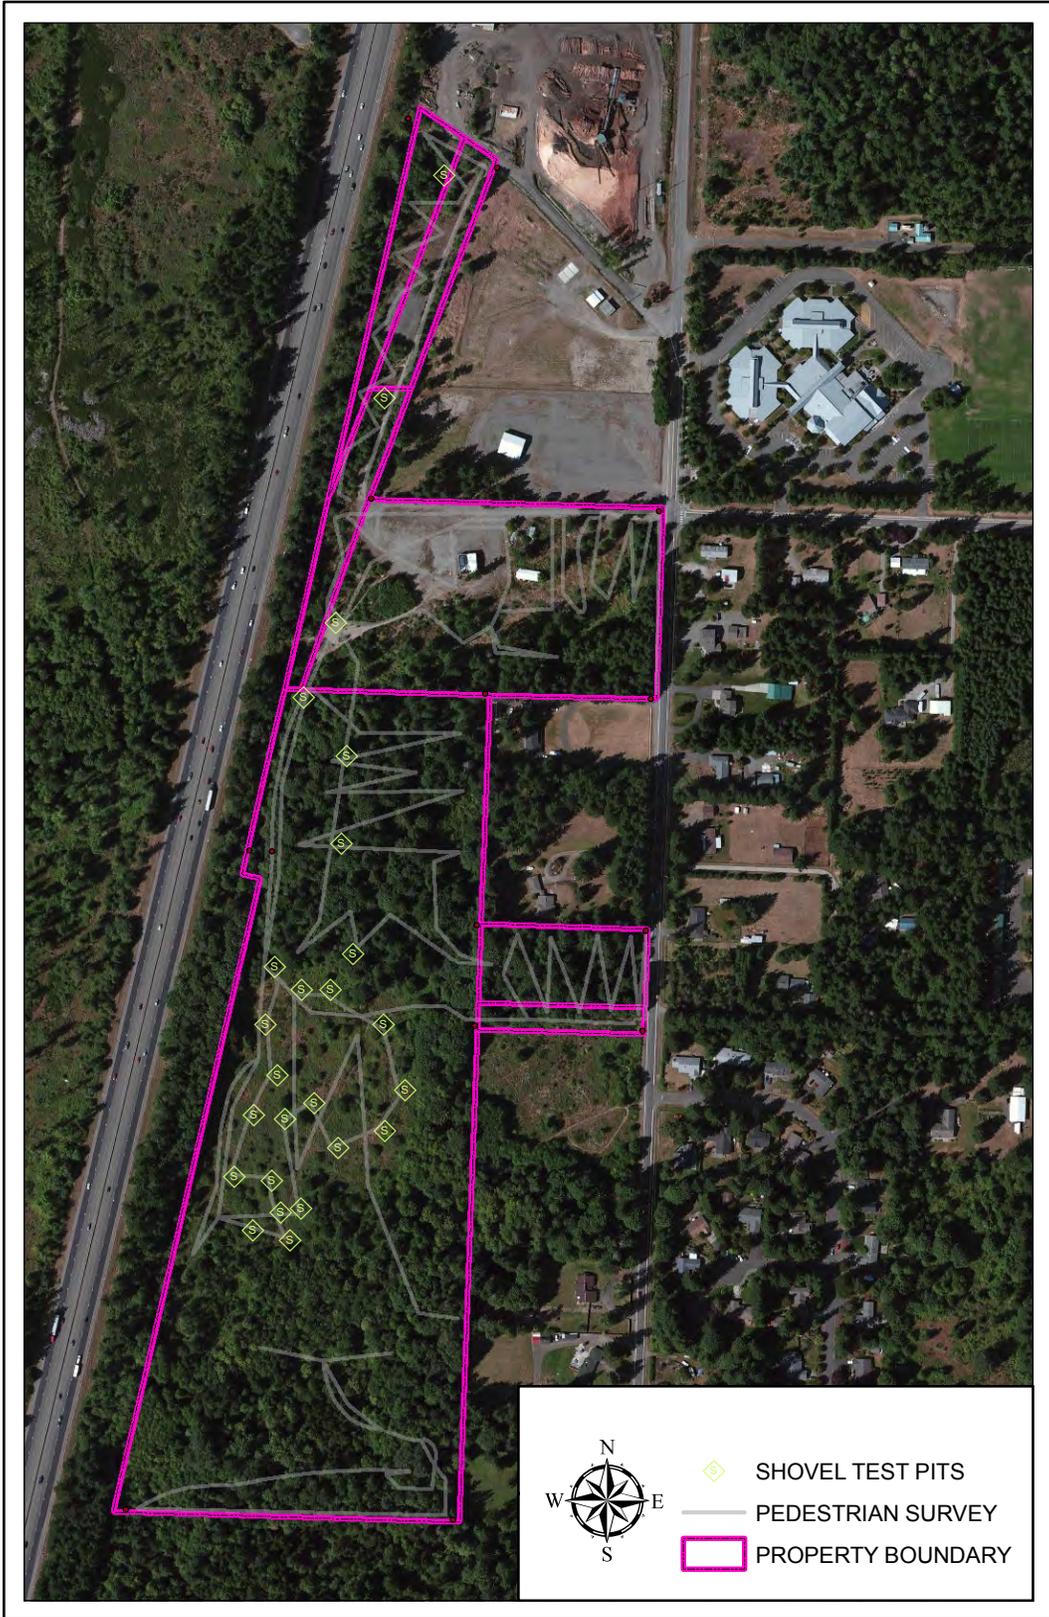
Figure 16. Shovel probe locations in the APE.

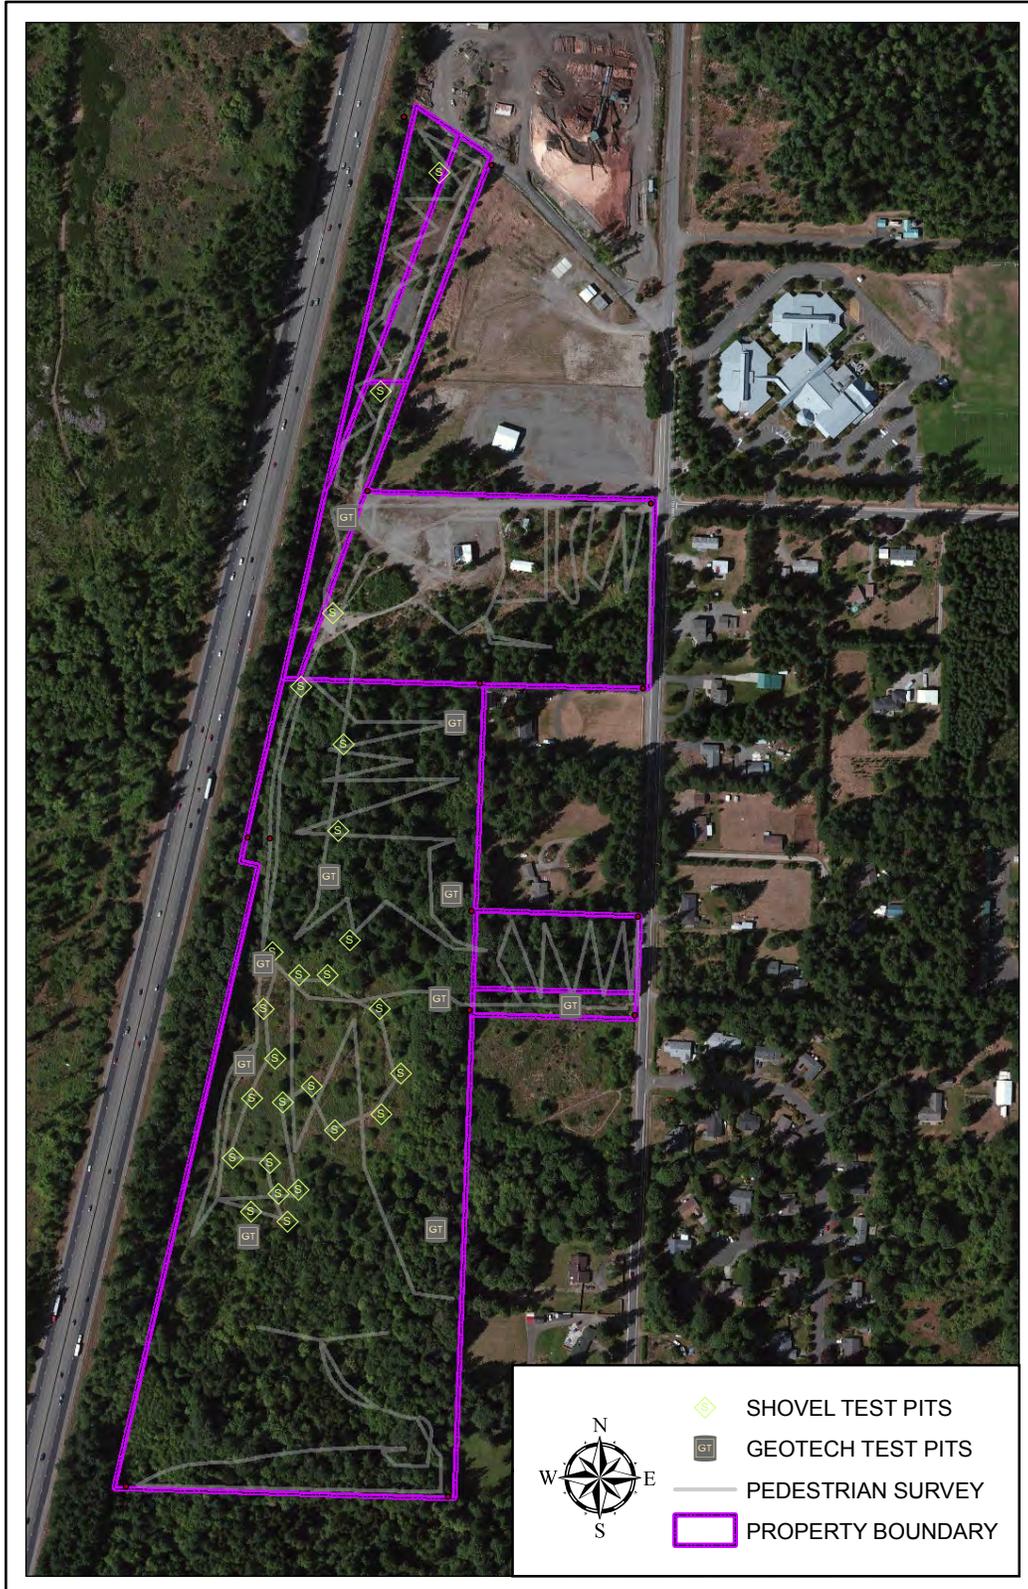
Figure 17. Composite map with project plan, geotechnical assay locations, survey transects and shovel probe locations.

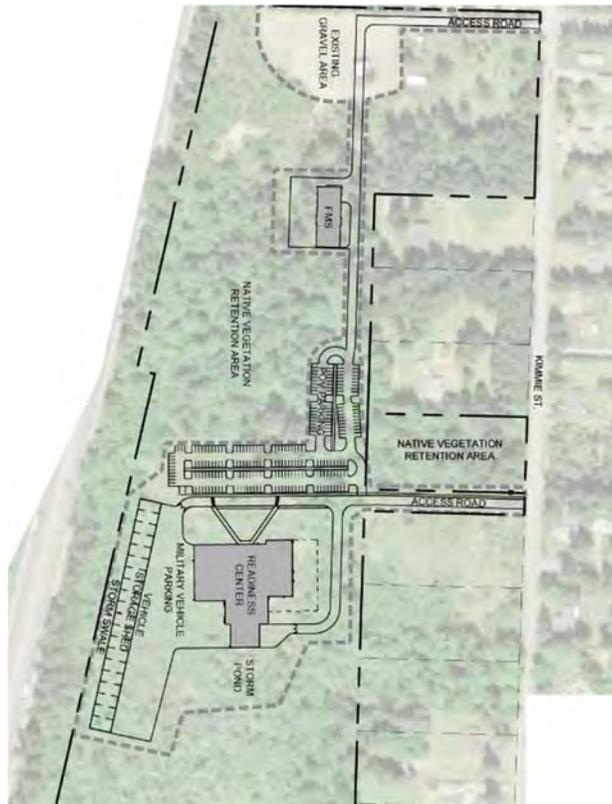
Figure 1: Preliminary TRC Site Plan

This memorandum summarizes our review of transportation conditions and potential impacts for the proposed National Guard Readiness Center located in the City of Tumwater. The project would involve the construction of a readiness center for the Washington Military Department and National Guard that would consist of two building structures<sup>1</sup> with access proposed onto Kimmie Street SW south of the 83rd Avenue SW intersection. The project is anticipated to be constructed and occupied by 2019. Figure 1 shows a preliminary site plan.

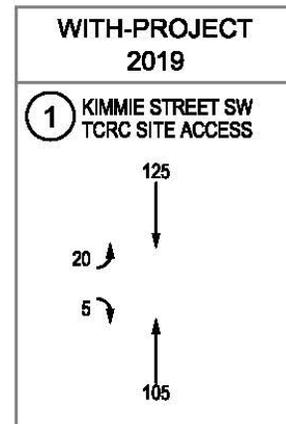
Figure 3 – 2019 Weekday PM Peak Hour With-Project Traffic Volumes

Existing traffic volumes were collected along the project frontage on Kimmie Street SW on a weekday PM commute peak period when public schools were in session, which corresponds to the typical overall peak traffic volume period. Detailed turning movement worksheets are provided in Attachment A. Approximately 95 vehicles traveled northbound and 115 vehicles traveled southbound along the project frontage during the PM peak hour. These volumes were then grown by 2-percent each year to 2019 conditions, resulting in 105 northbound and 125 southbound vehicles. Project traffic was assigned to the driveway consistent with Table 1. Figure 3 illustrates the forecast 2019 with-project weekday PM peak hour volumes.
