## Final Hazard Profile – Landslide

### Landslide

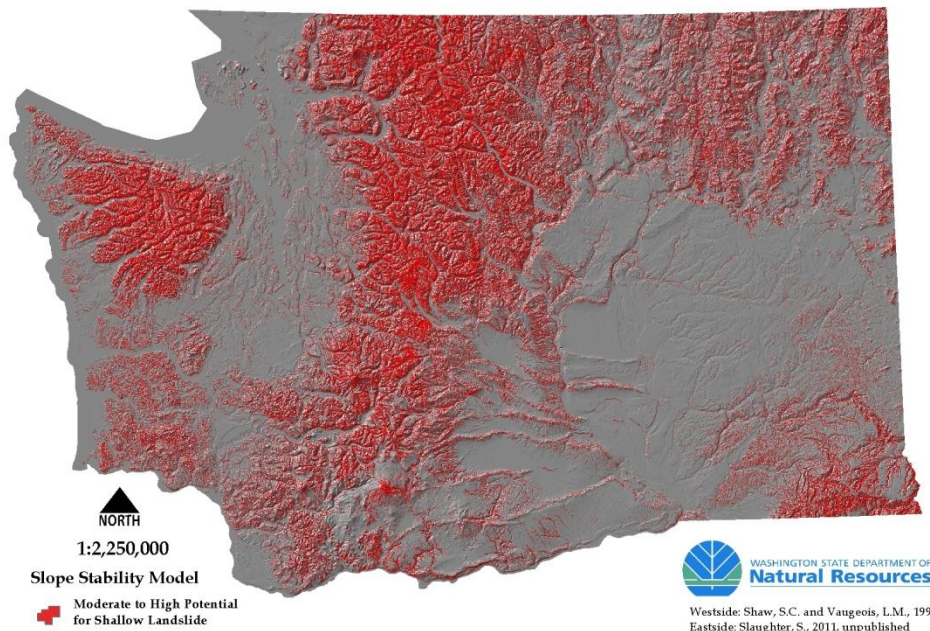
Slope Stability Model for Shallow Landslide Potential  
West and East side

The landslide hazard map for Washington (Figure 1) was derived from the United States Geological Survey (USGS)<sup>1</sup> open-file report titled, Landslide Overview Map of the Conterminous United States. A GIS data file was obtained for this map from the USGS and the landslide hazards for Washington were extracted to create the map. Landslide hazard areas are colored similar to the colors used for the original U.S. map. The landslide hazard is based on either the landslide incidence or the susceptibility of a landslide to occur in a given area. Susceptibility is not indicated on the map where it is the same or lower than incidence. Susceptibility to landslides was defined as the probable degree of response of [the areal] rocks and soils to natural or artificial cutting or loading of slopes, or to anomalous high precipitation. High, moderate and low susceptibility are delimited by the same percentages used in classifying the incidence of landslides.

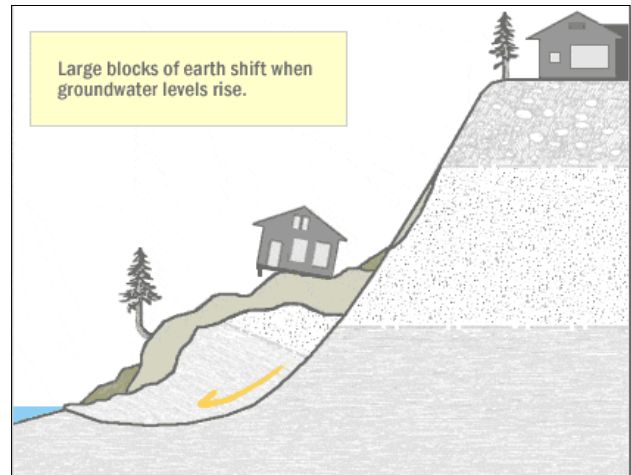
Figure 2 Deep-seated Landslide

Figure 2 shows a deep-seated landslide. This type of slide can be ancient and may persist for several millennia. These slides can reactivate every few years to decades in response to particularly wet conditions. Typically, these large slides range in area from less than an acre to several that extend over a mile of shoreline. The large ones often consist of several smaller blocks that may move independently.<sup>8</sup> The deep-seated slide in figure 2 is rotational, which means it rotates the earth and rock backward as gravity pulls the mass of the slide downward. This type of landslide has been seen all over Washington, with a recent occurrence in 1999 at Carlyon Beach near the city of Olympia, which forced over thirty families from their homes.

Landslides can also into two major categories, deep-seated landslides, which fail below the rooting depth of vegetation (Figure 2) or shallow (Figure 3). This distinction is important to evaluating the potential effectiveness of mitigation measures such as vegetation management. Shallow landslides tend to respond to rainfall events over periods of days or weeks, whereas deep-seated slides respond to weather over periods of months, years, or even decades. In the Washington Geological Survey's statewide landslide database (Sarikhani and Davis, 2008), landslides are categorized into the following groups:

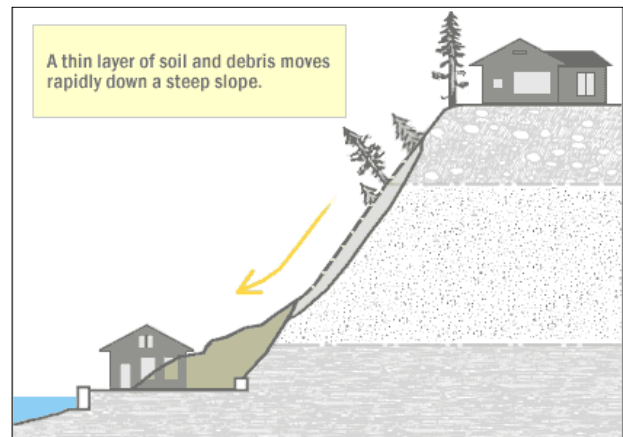
Figure 3 Shallow Landslide

Figure 3 shows a shallow slide. These slides are frequent and widespread along Puget Sound shoreline, typically occurring during prolonged periods of heavy rainfall. They involve a relatively thin layer (commonly less than five feet) of wet soil and vegetation, but can be dangerous, as mud and debris can travel fast and with destructive force. These slides are usually small and rarely result in serious widespread damage, although large storms can trigger hundreds or even thousands of shallow landslides, usually debris flows. The greatest danger from this type of slide is to homes or structures built close to the toe of the slope, where they may be struck or buried by rapidly moving mud and debris.

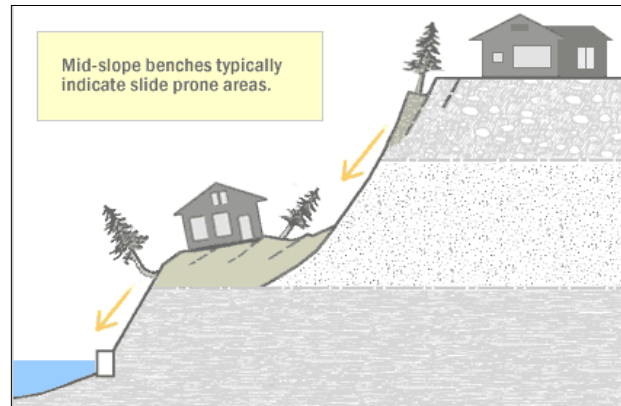
Figure 4 Bench Landslide

Figure 4 shows a bench formation, in which permeable sediments, typically sand, overlie impermeable sediments, leading to weakening and failure of the sand. Benches may occur along layers of resistant geologic materials, where long term erosion or land sliding of the overlying units has produced a stepped slope. Benches present an attractive site for development, since they offer level ground near the water on otherwise steep terrain. In many places, roads have been built down the steep upper slope to serve home sites along the bench itself. Examples of benches can be seen along the shoreline north of Kingston, above the railroad grade north of Carkeek Park in Seattle and on Magnolia Bluff in Seattle.

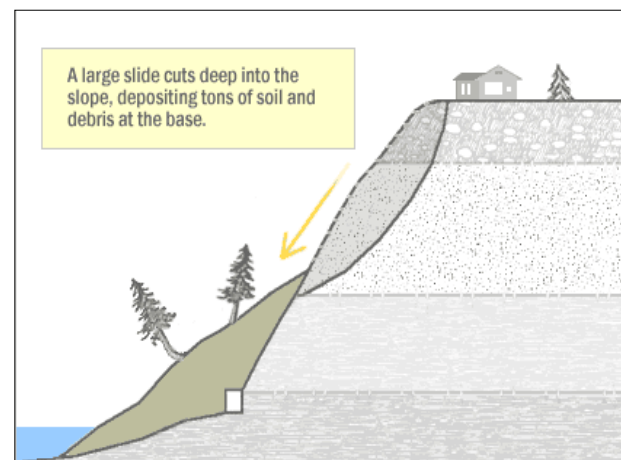
Figure 5 Large Scale Landslide

Figure 5 shows a large-scale landslide which are relatively rare but do periodically strike the Puget Sound's shoreline, as the large landslide that destroyed 36 homes at Carlyon Beach in Thurston County. As with any geologic hazard, small events are more common than large ones.

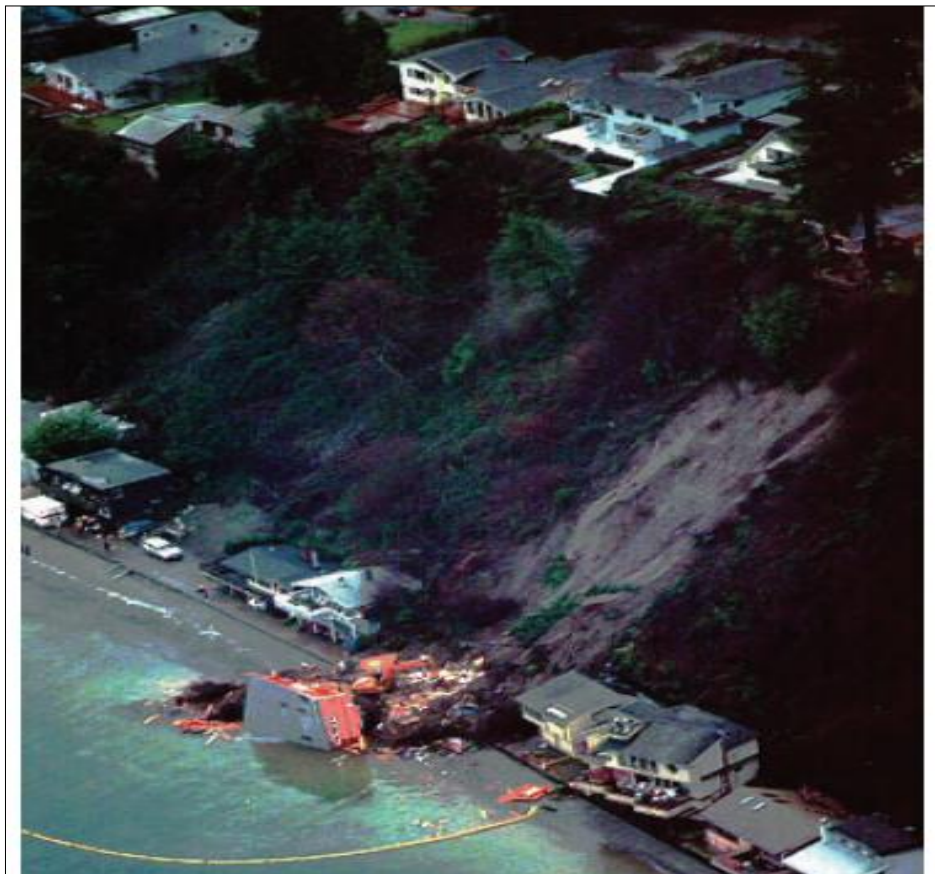
**Figure 6** Rolling Bay, Bainbridge Island Landslide, 1997

One widely publicized landslide from the 1997 event resulted in the deaths of four family members when a shallow debris flow landslide on Bainbridge Island, completely consumed and destroyed their home (Figure 6).

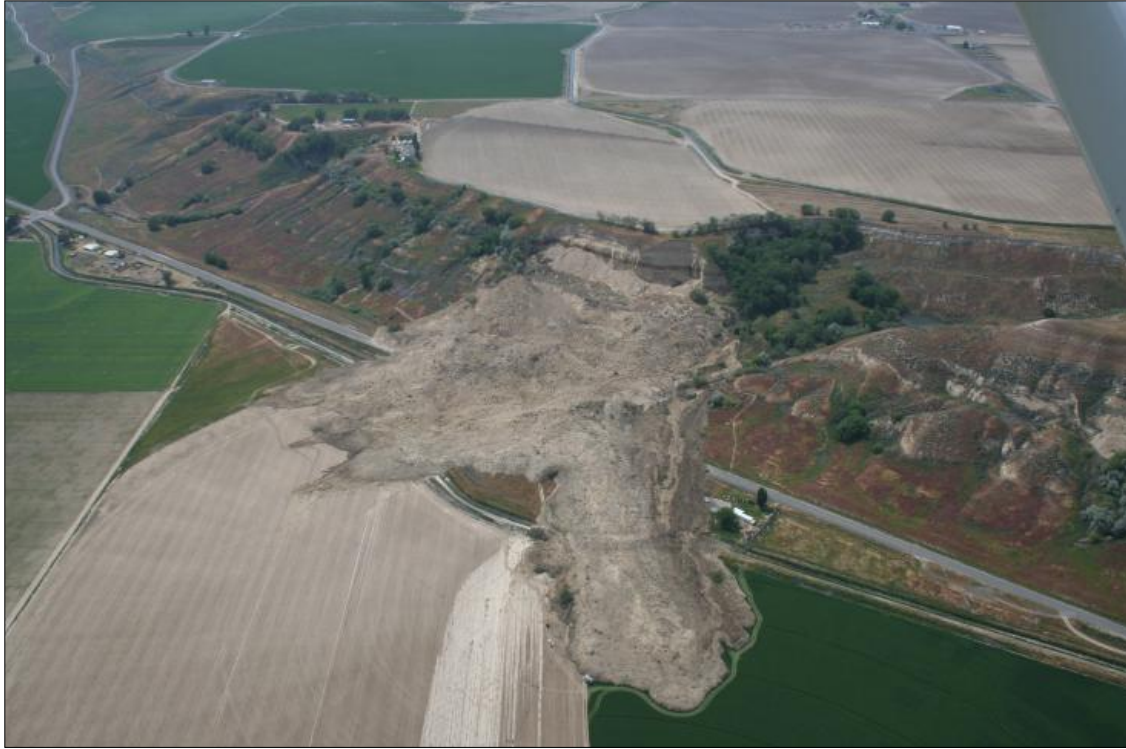
Figure 8. At about 9 p.m. on Saturday, May 13, 2006, a large section of bluff sloughed off and covered about a quarter-mile of Road 170 to a depth of about 40 feet. Photo courtesy of the South Columbia Basin Irrigation District.

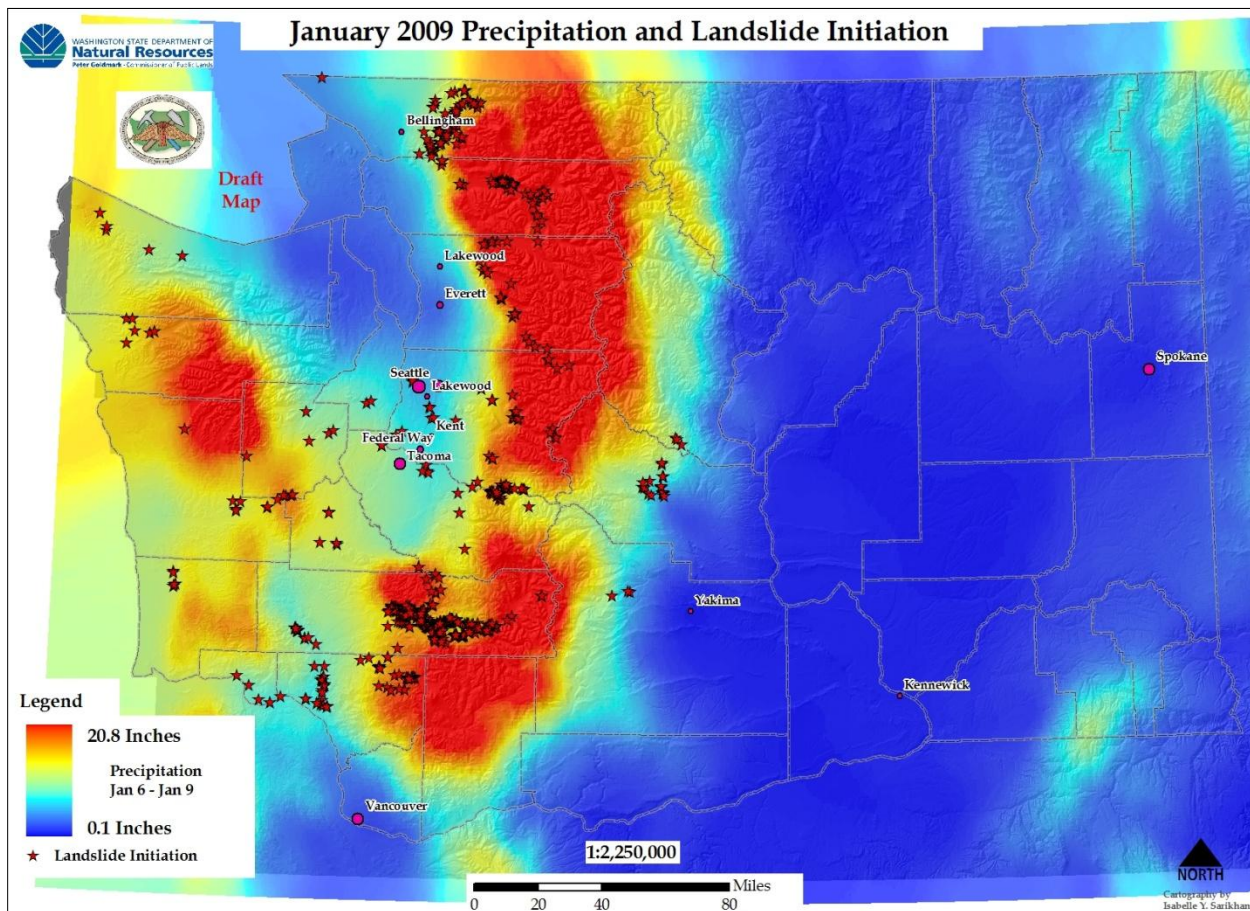
Figure 11. January 7-8, 2009 storm and landslide initiation.

In Lewis County, hundreds of debris flows between Morton and Randle flowed into the valley, destroying houses and blocking Highway 12. The debris flows were very long reaching, often transforming into hyperconcentrated flows on the valley floor and moving for miles downstream. Many of the hyperconcentrated flows were channelized into roadways by plowed snow from earlier snow storm events. Over 500 landslides were recorded in Eastern Lewis County with an unknown number of houses damaged. No deaths were reported.

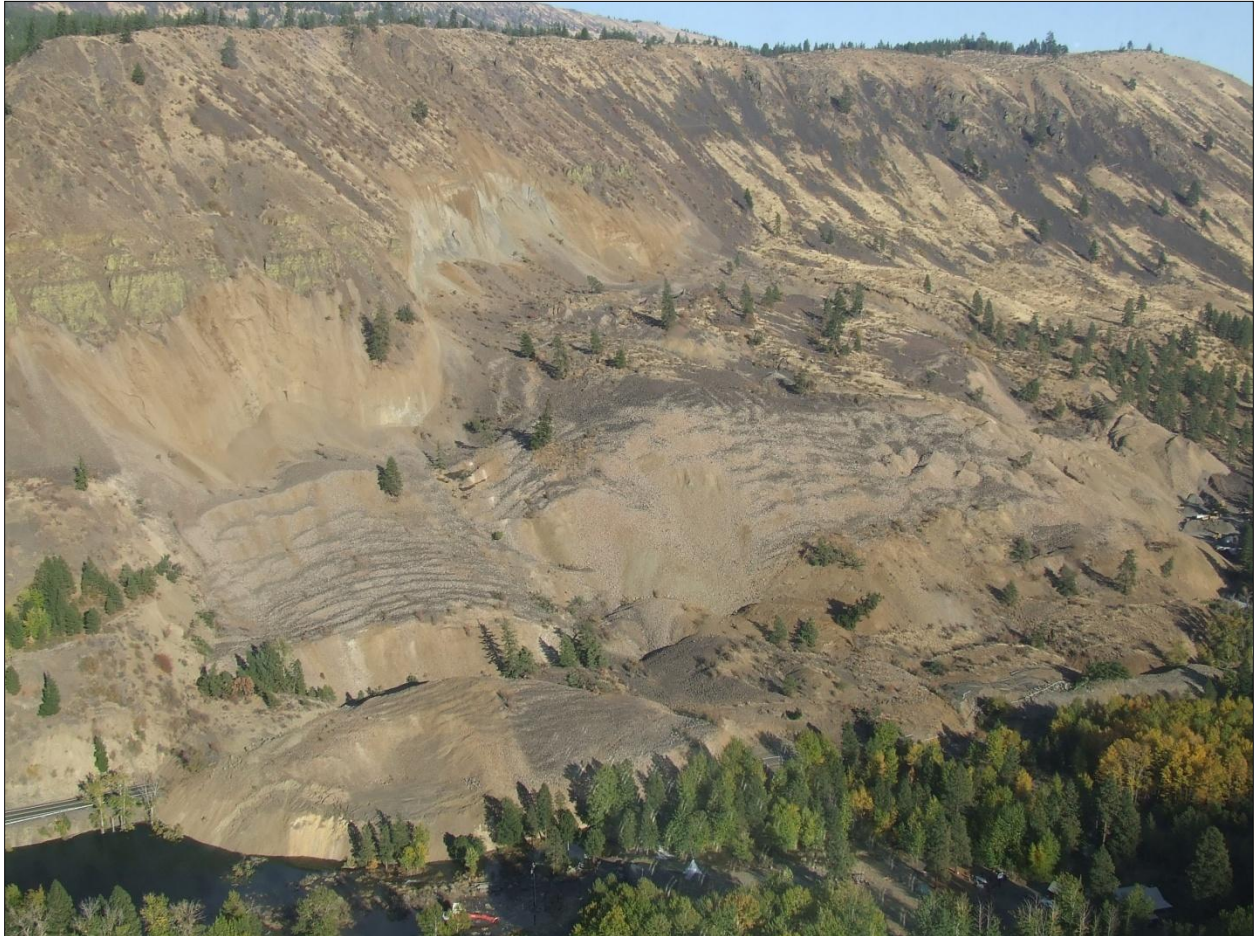
A massive landslide started to move on October 10<sup>th</sup> west of Naches near the town of Nile. On October 11<sup>th</sup>, the landslide catastrophically failed, diverting the Naches River covering Highway 410, and damaging 6 houses by ground deformation and over 20 homes by flooding.

Figure 12. An oblique photo of the Nile Landslide, photo by Jack Powell, DNR

Following the landslide movement Yakima County purchased 60 acres of land that included several homes at a cost of \$1.78 million to realign the Naches River channel and a new road. WSDOT constructed a temporary route for Highway 410 on the other side of the valley. In response to the danger of the landslide, WSDOT, DNR, and the University of Washington monitored the landslide for movement. A radar system was employed to monitor landslide movement, monuments were set up on the landslide and portable seismometers were utilized

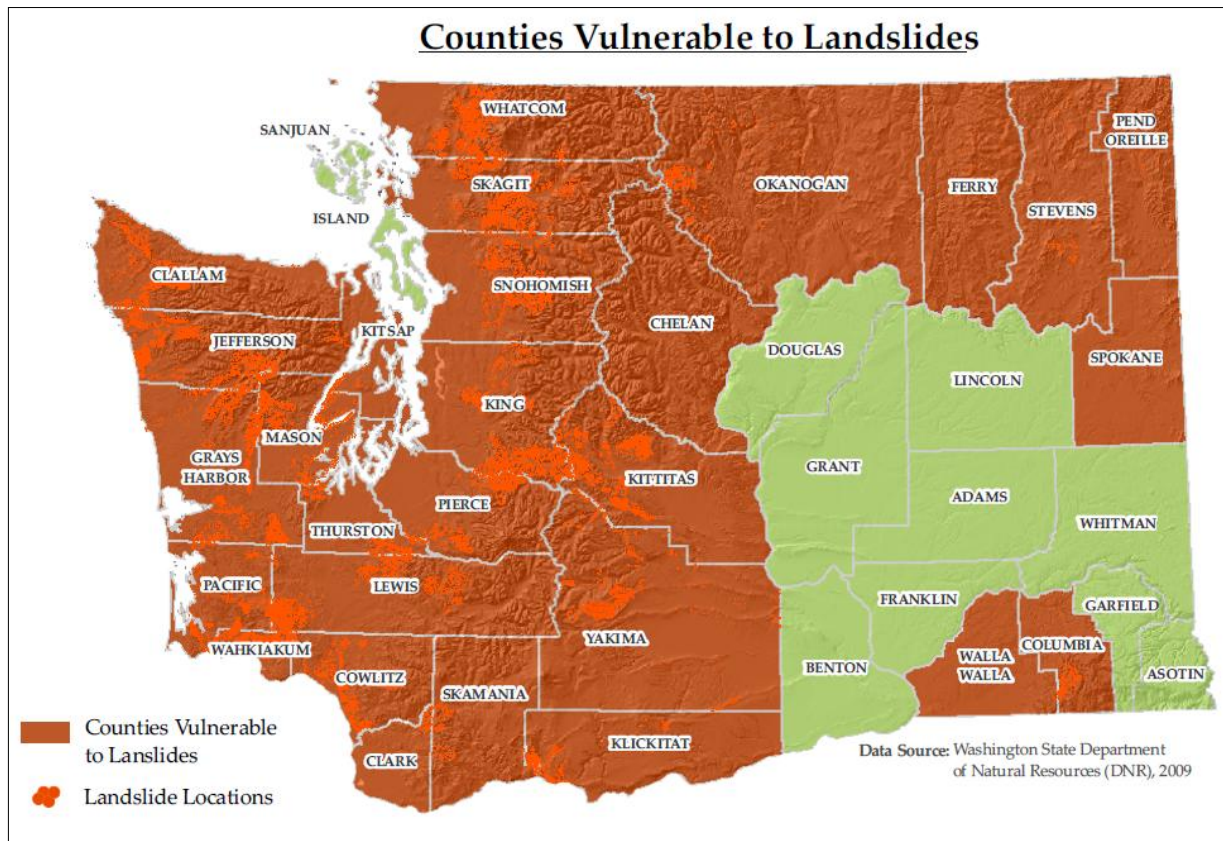
Analysis of risk to local jurisdictions is a difficult process. Currently, there are no comprehensive statewide landslide hazard maps. However, models exist to aid in detecting potential areas more susceptible to landslides in some locations. All counties in Washington State have some landslide hazard and risk. In Washington State, landslide risk is higher in western Washington due to the higher amount of precipitation. Water and gravity are the main drivers of landslides. In Eastern Washington, the landslide risk is high during storm events (especially spring and summer thunderstorms) and in places where irrigation is near bluffs or near or on deep-seated landslides. Earthquakes have the potential to cause landslides in Eastern and Western Washington.

Figure 13. Counties Vulnerable to Landslide Hazards. Counties within in Washington State that contain known landslides are considered at-risk to future landslide activity.

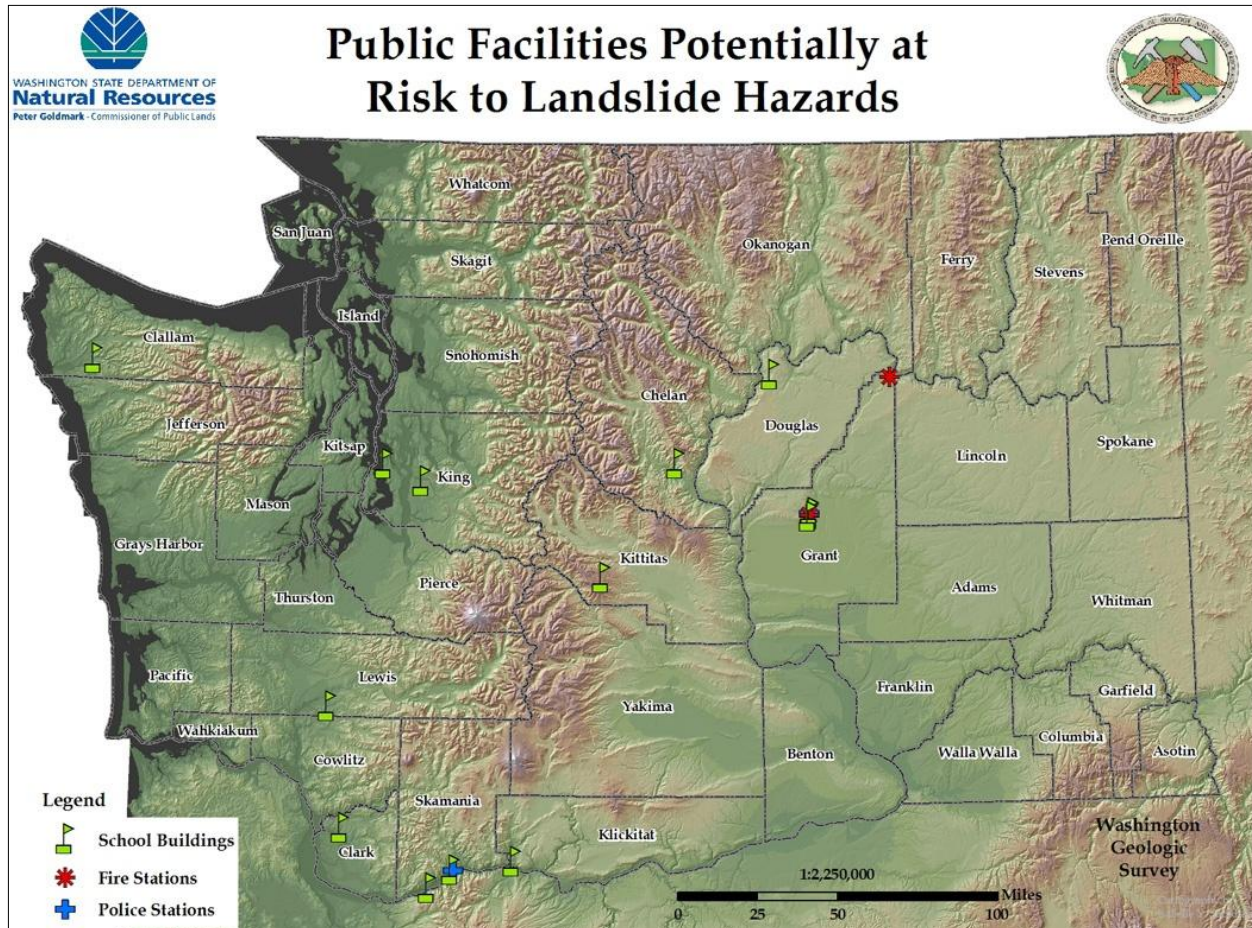
Since no statewide landslide susceptibility map exists, a detailed analysis of public facilities is difficult. However, a simple analysis of public facilities on or nearby landslides indicates 23 facilities potentially at risk of future landslide activity. The risk could include reactivation of a deep-seated landslide or in areas susceptible to shallow landslides, such as debris flows. This simple analysis does not exclude features not shown on the map from landslide risk.

Figure 14. Public facilities in or within 100 feet of a landslide within the Washington Geologic Surveys landslide database. These facilities are potentially at risk for future landslide activity.

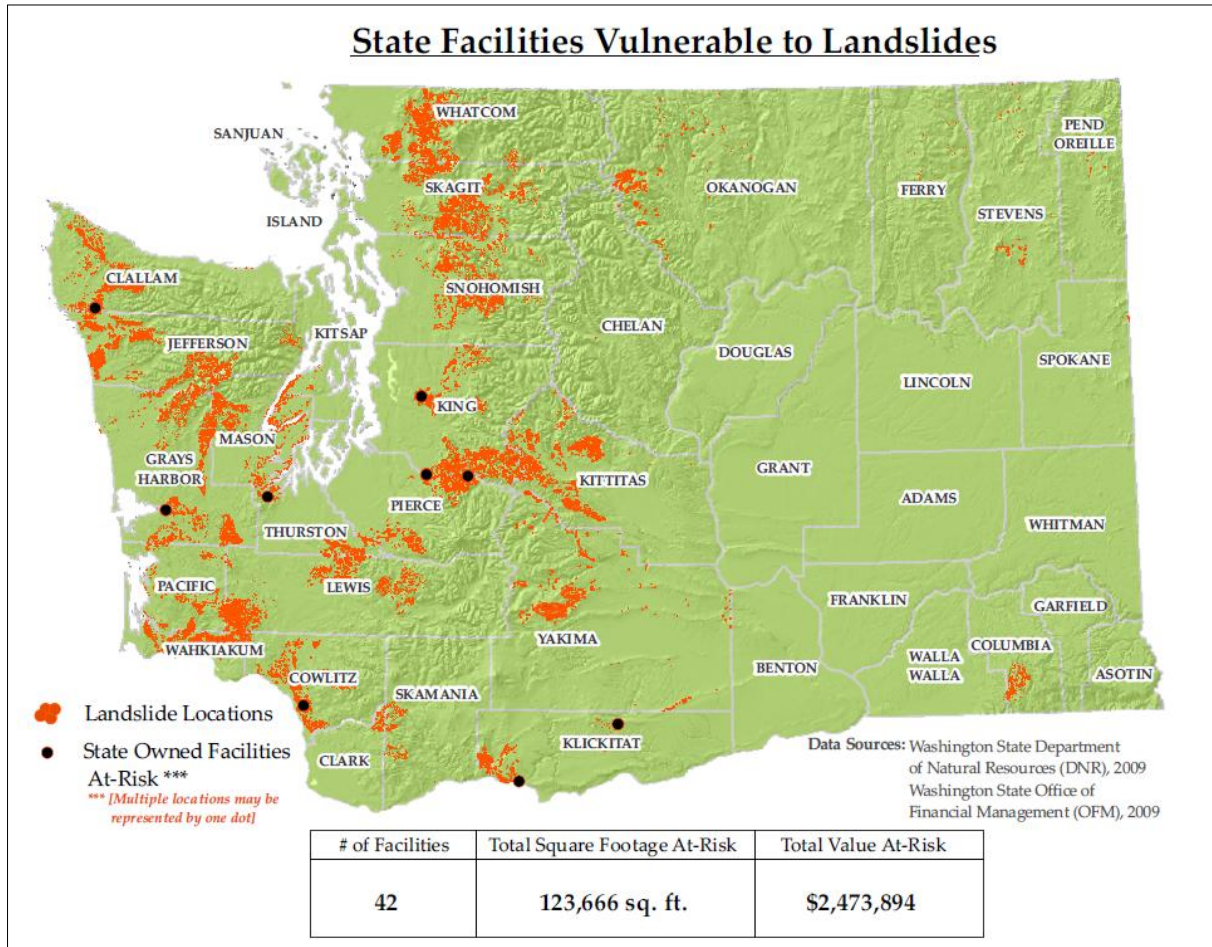
Utilizing the Washington State Office of Financial Managements 2009 dataset of state leased and owned facilities, an analysis was performed to determine which, if any, state facilities may be at risk to a future landslide. For the state leased facilities in this dataset, 42 were determined to be within 500 feet of a landslide and may therefore be at risk to future landslide activity. These state owned facilities represent over 123,000 square feet of office space with a total value of over \$2.4 million dollars. An identical analysis of state leased facilities was performed, but no state leased facilities were determined to be within the specified distance of any known landslide location contained in the landslide database.

**Figure 15. State Owned Facilities within 500 feet a location of a known landslide according to the Washington Geologic Survey's 2009 Landslide Database at 24K.**
