Batteries in Recycling Transport Explosions

How, Why, Prevention, Mitigation

Robert L. Swaim

Birmingham Dry Van (Box) Trailer Case Study

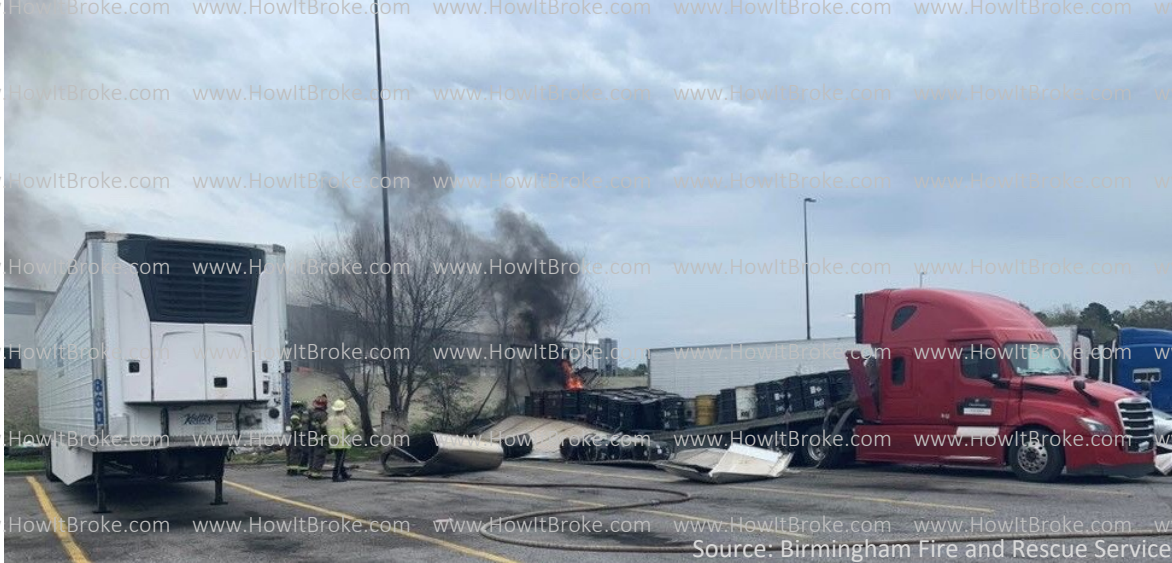
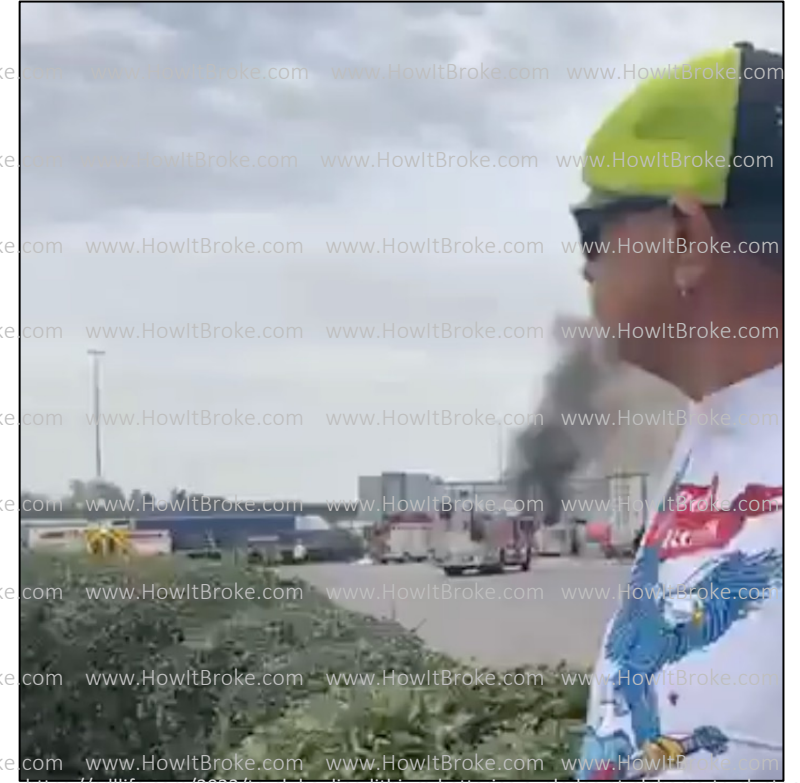
Flying J Truck Stop, 3/31/2023

**Initial witness watches fire response arrive
Note confined fire/smoke at rear**

Dry van (box) trailer contained barrels of batteries to be recycled

Driver drove about 1,800 miles from Las Vegas, NV

Parked two days before explosion to visit family

Witnesses reported roof reached 70 feet

Barrels of batteries found marked Class 9

Barrel contents found inadequately packaged

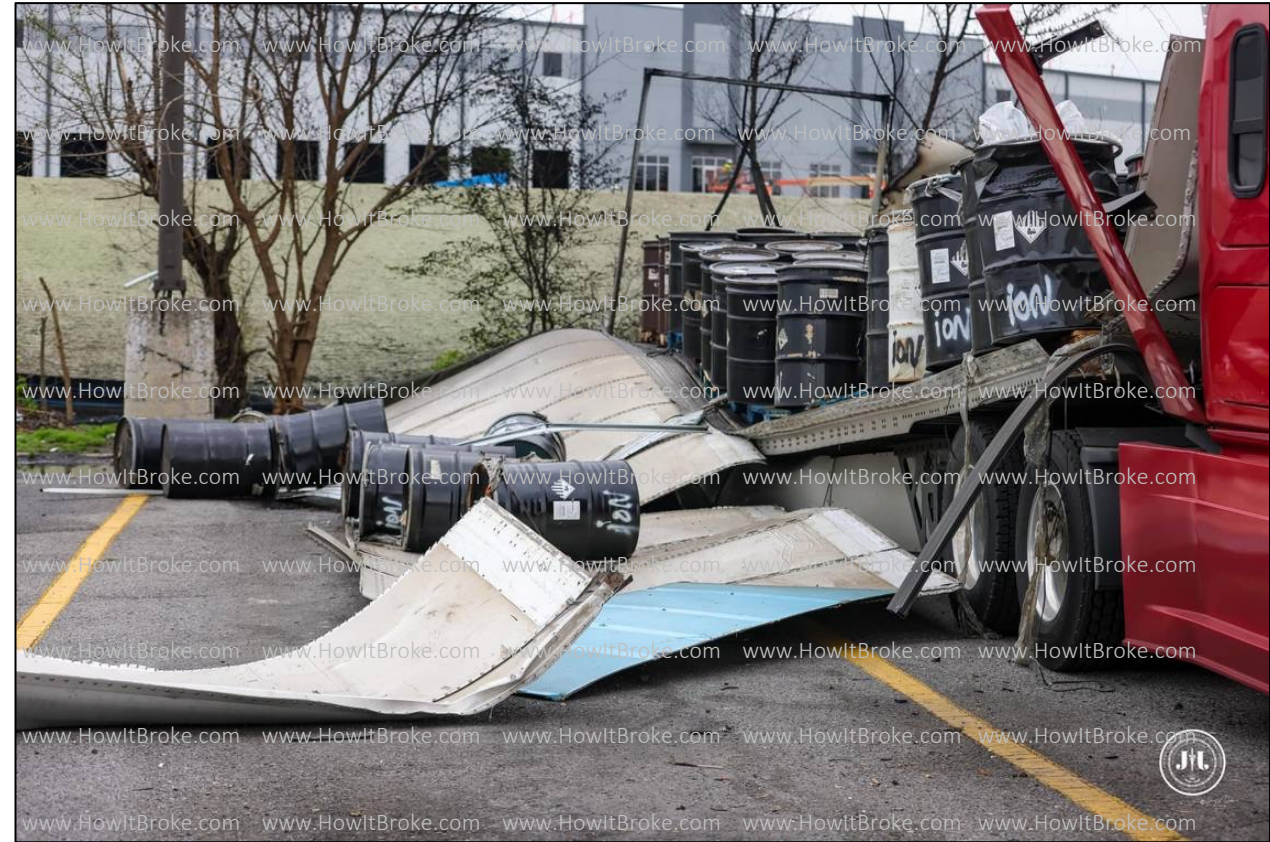
Trailer details

Manufactured by Strickland

53 foot dry van, unvented box

4,035 cu.ft. interior volume

35,243 lbs weight, 33,753 lb net cargo

26 pallets loaded with 104 drums, 55 gallon

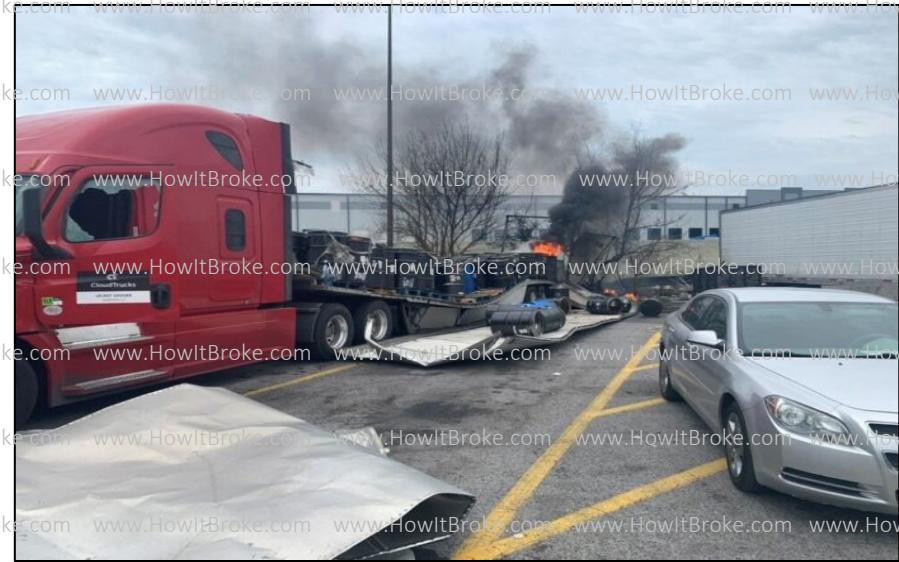
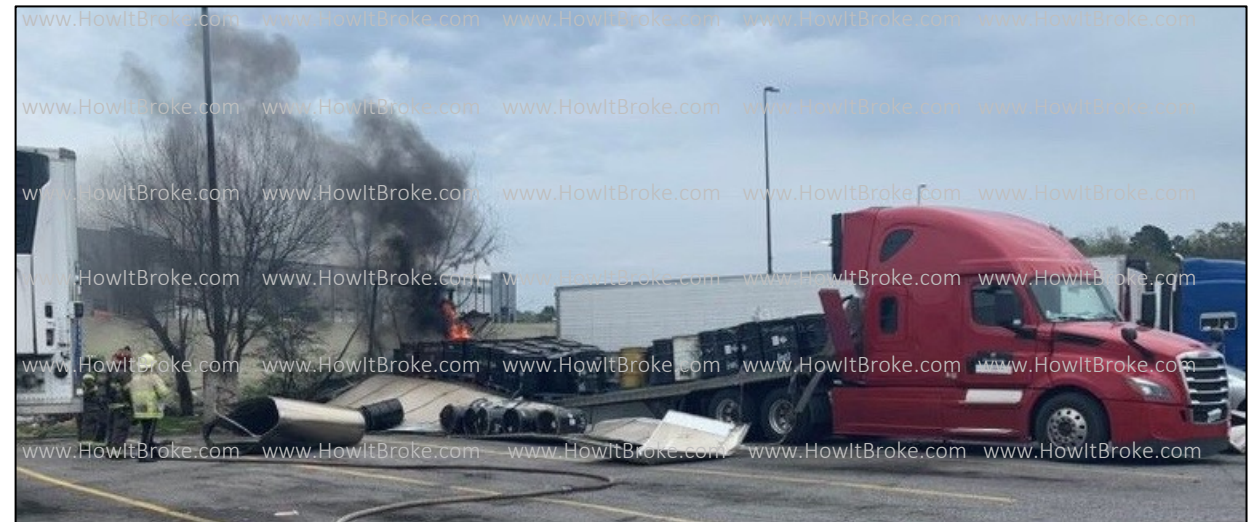
Damage found

Floor displaced downward to ground ahead of rear wheels

Right rear door separated

Aluminum roof separated into three pieces

Aft third and mid landed to right of trailer

Forward portion landed to left of tractor more damaged

Left sidewall

Total separation relatively intact

Tearing from front ragged at front

Right sidewall

Aft half folded down from top and remained attached

Forward portions smaller and completely separated

Front wall displaced forward into sleeper compartment of tractor with top folded aft

Some drums pulled during response

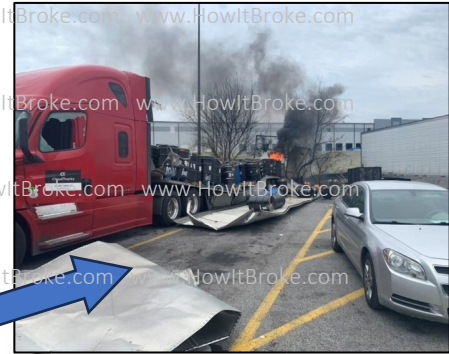
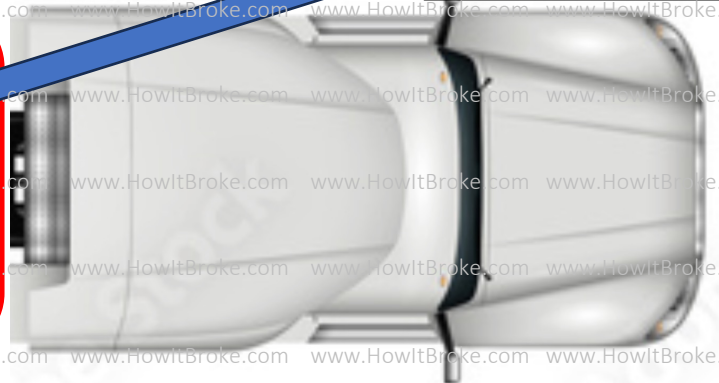
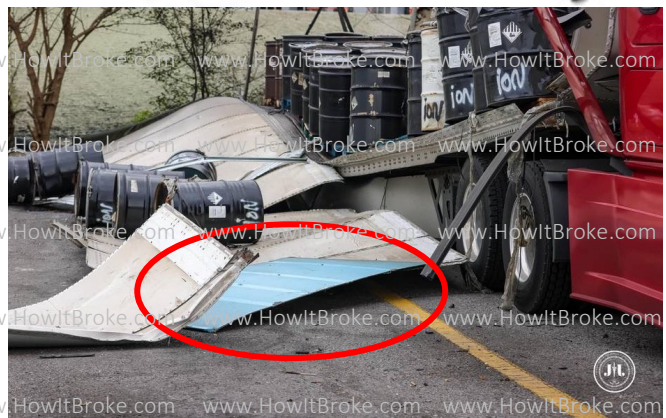
Evidence of Detonation – Roof Sections

Fwd roof fastener separations in tension

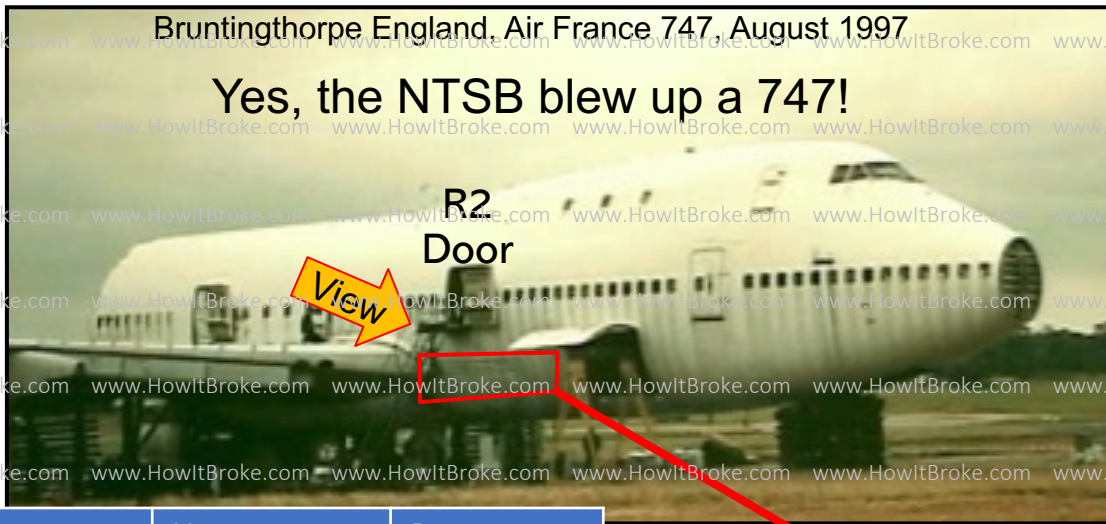
Quarter scale and other test explosions matched forward displaced SPWB #3 & Front Spar

Bruntingthorpe England, Air France 747, August 1997

View forward from CWT post-blast

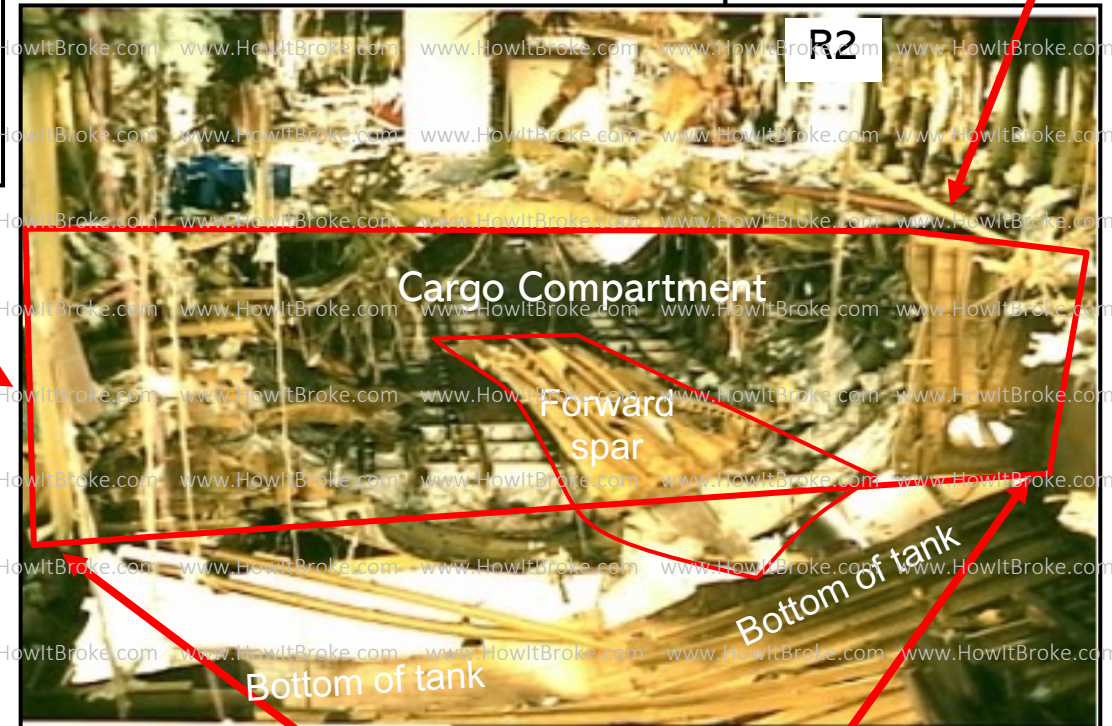
Forward cabin floor

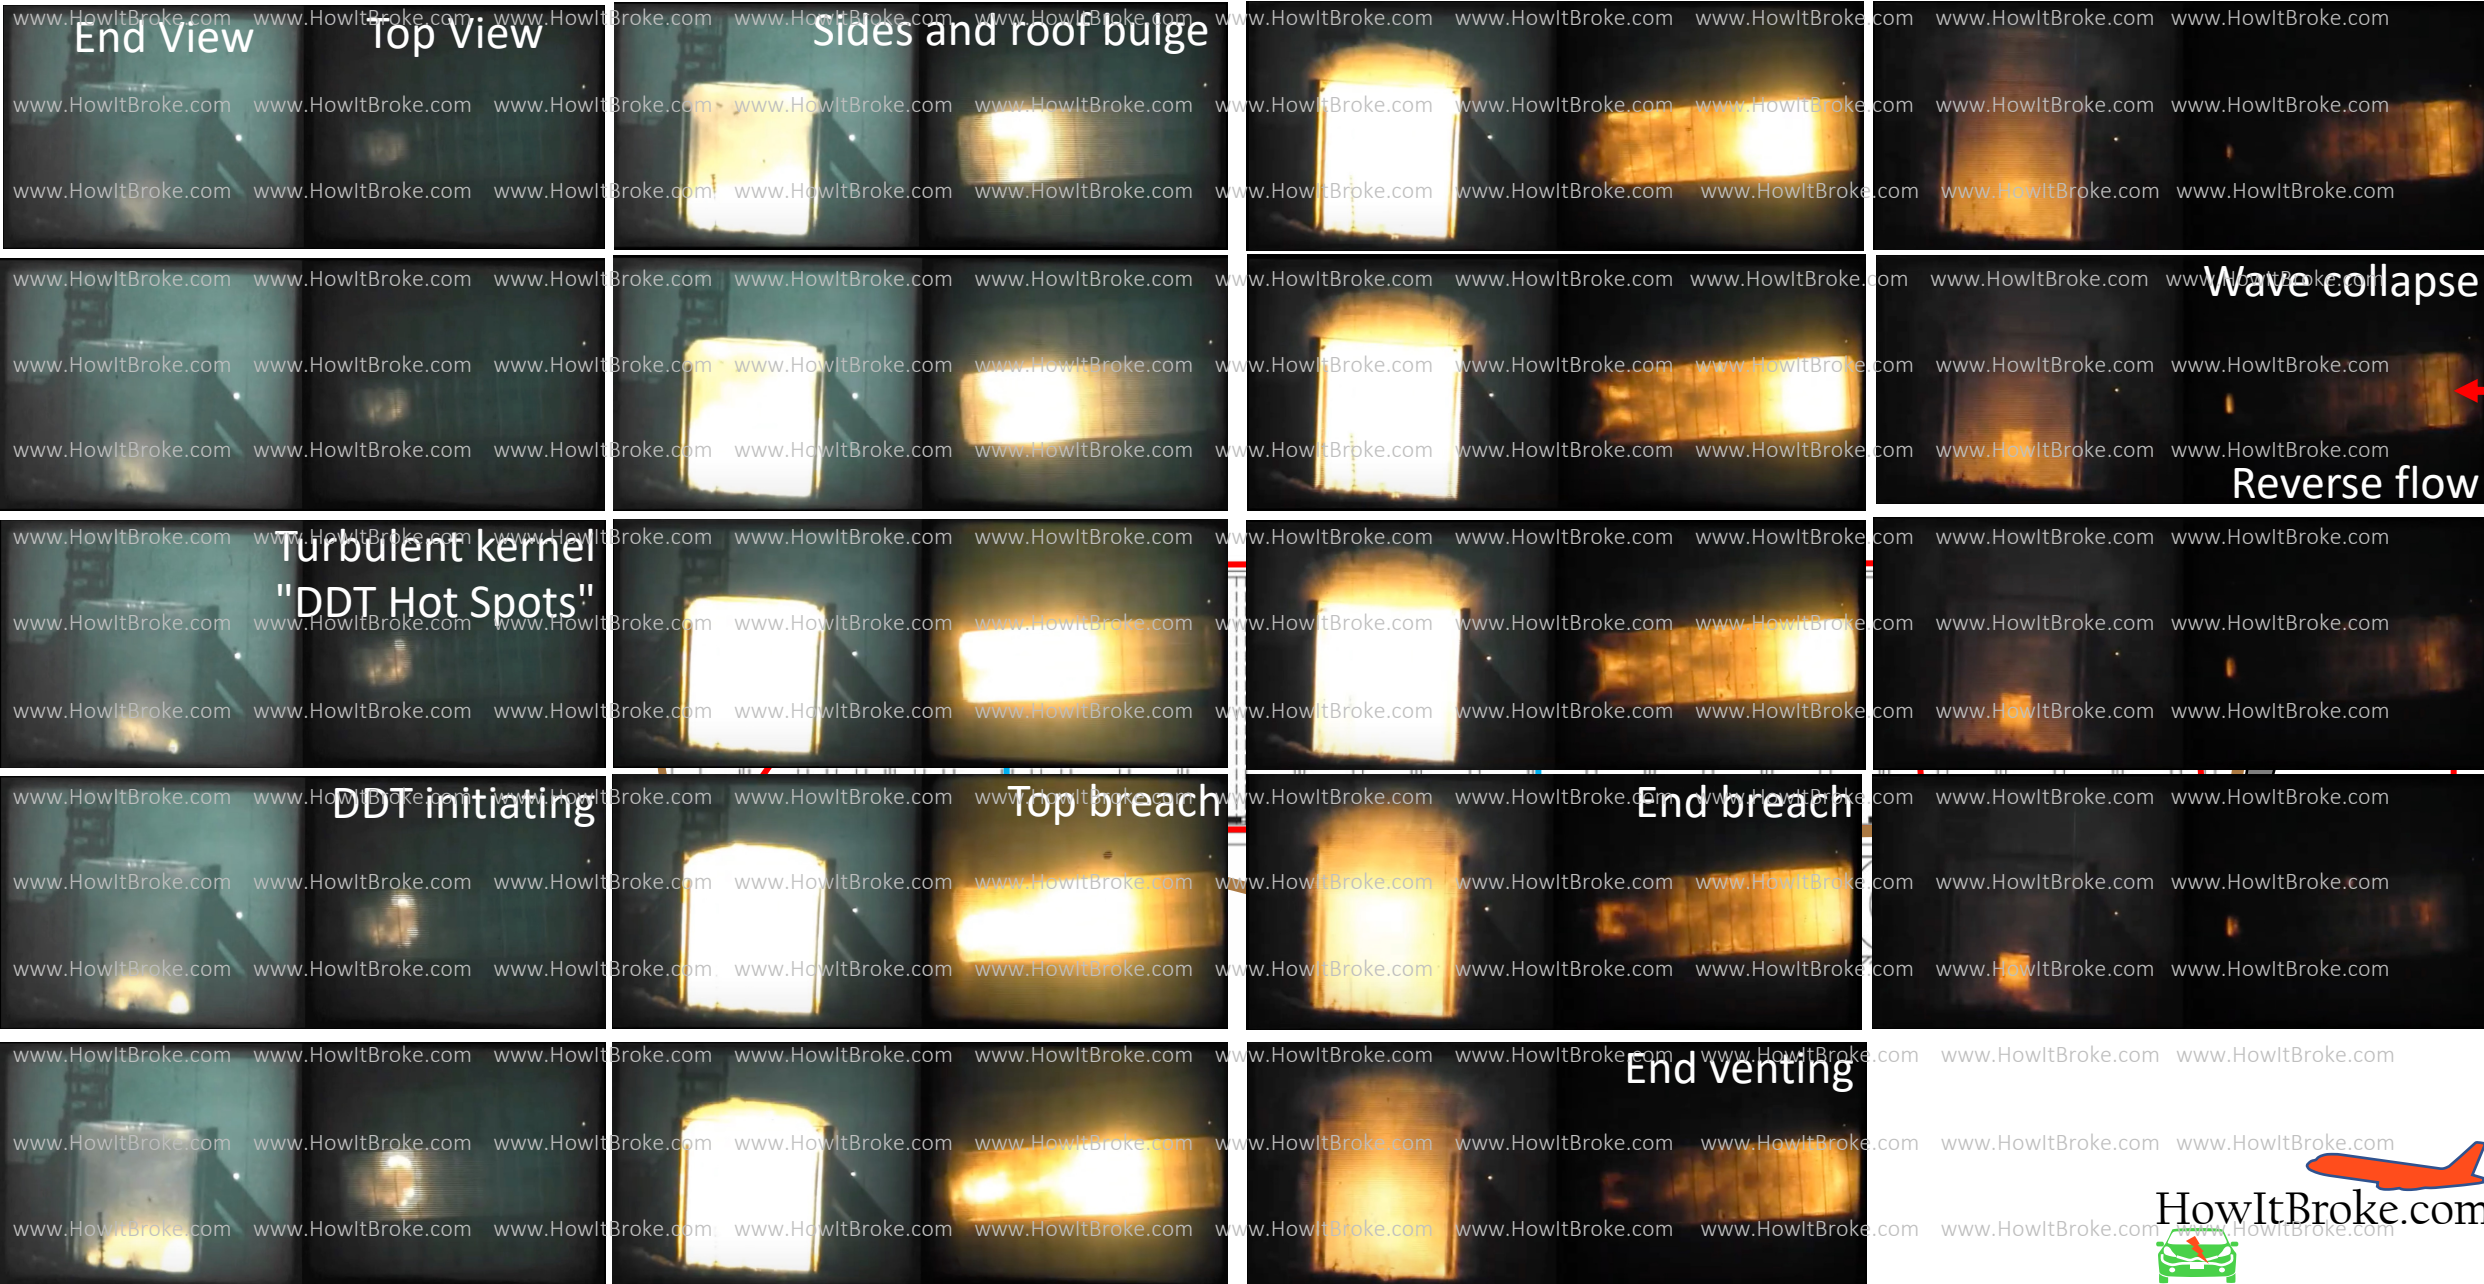
Matches Birmingham DDT Location

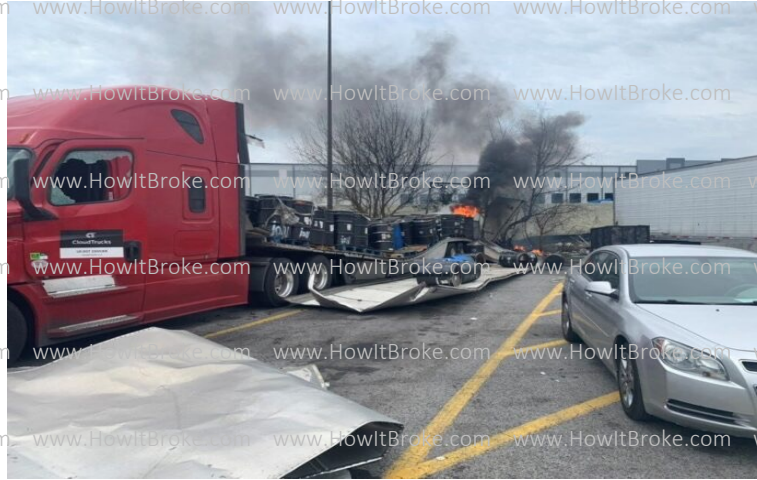
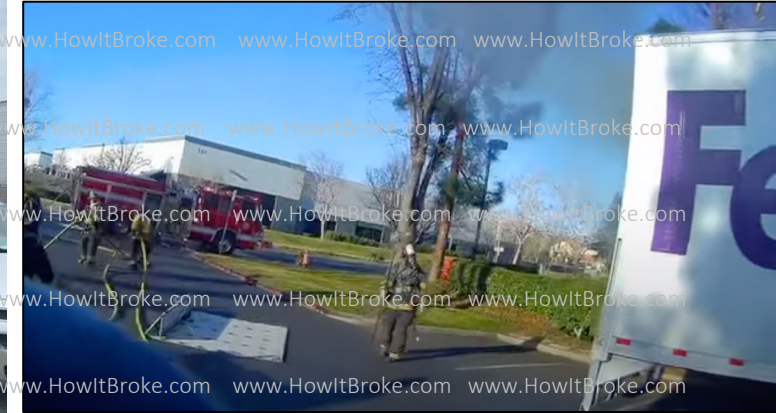
Extent of Damage Can Be Crude Indicator of Force

Indicator of fuel load in vapor cloud

Birmingham destroyed, 3/2023

Livermore relatively intact, 12/2023

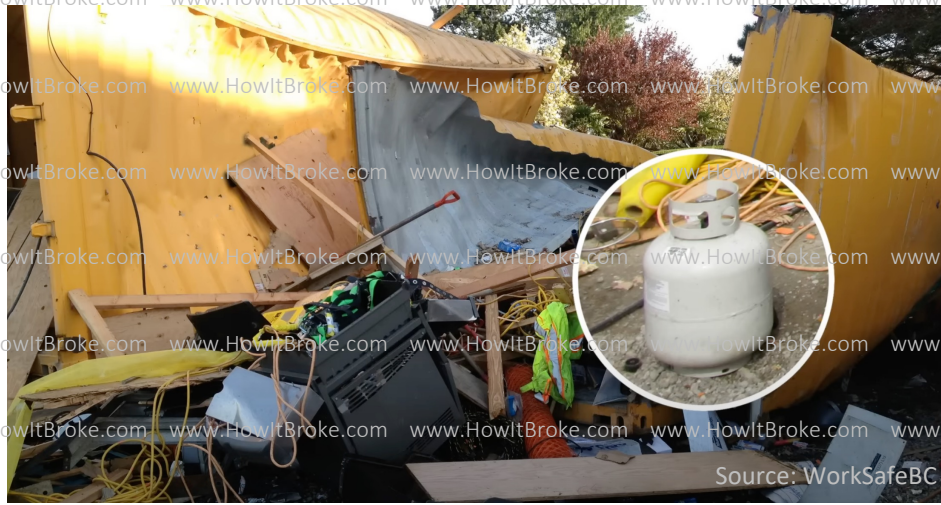
BBOQ Propane Tank, Vancouver, BC

20 lb Barbecue propane container has explosive force of about 100 kg (220 lbs) of TNT

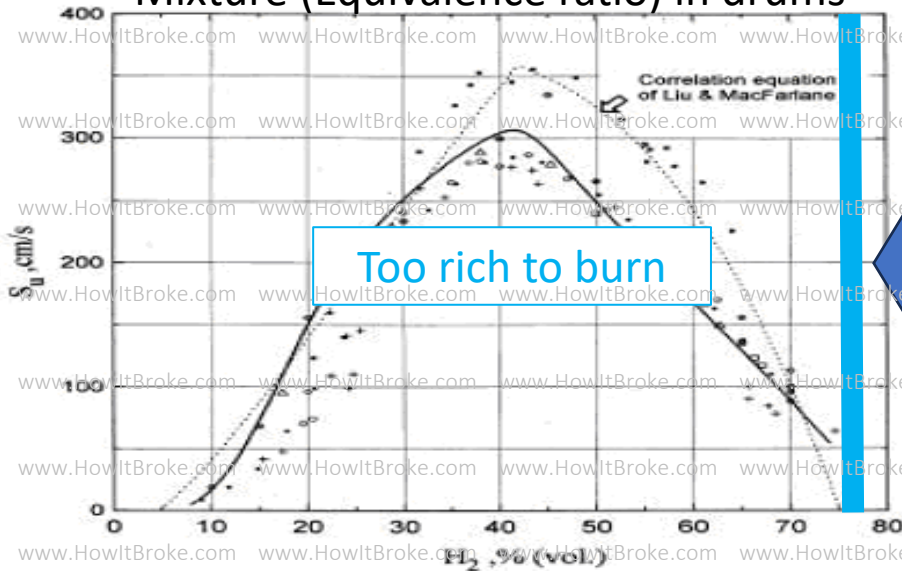
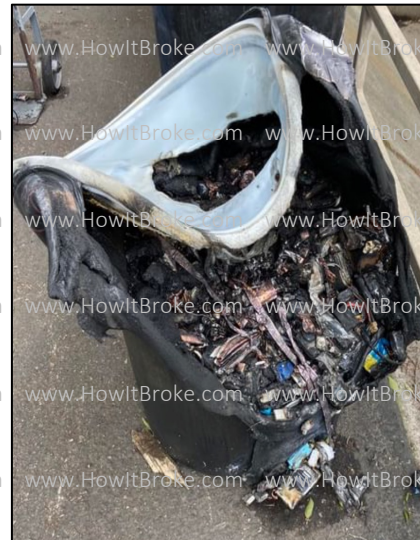
Drums could leak hydrogen into trailer at 4-14 psi for long period of time

Mixture (Equivalence ratio) in drums

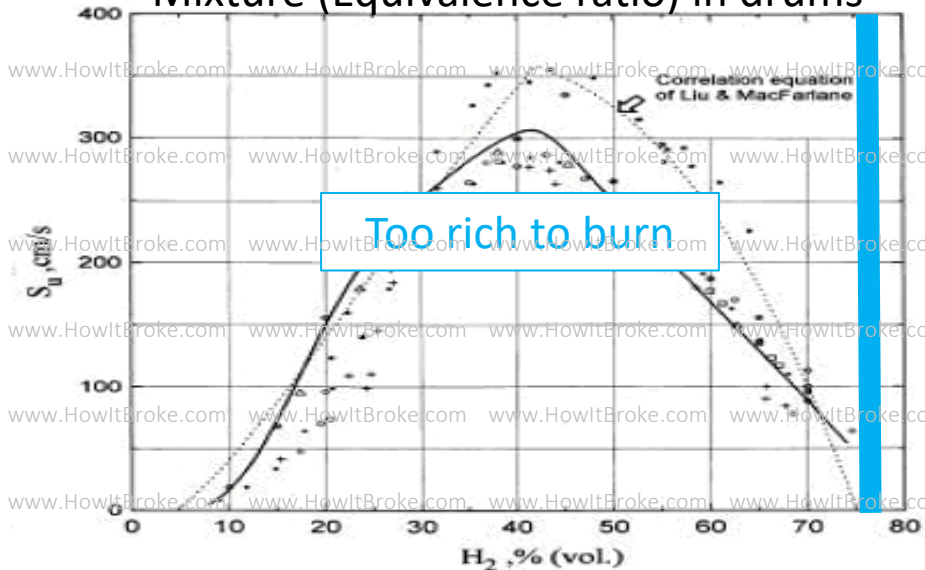
Flammability of Birmingham Drums Versus Trailer

Mixture (Equivalence ratio) in drums

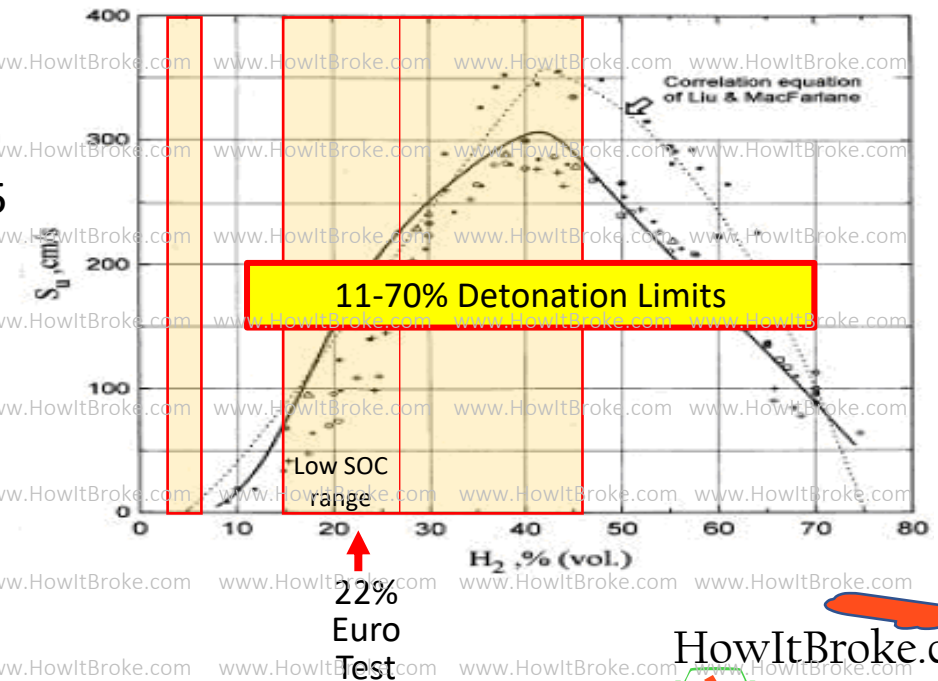
Volume of flammable gas in trailer

27% x 54.89% avg UFL = 14.8%

84% x 54.89% avg UFL = 46.1%

Vent gas volume in trailer =

27-84%

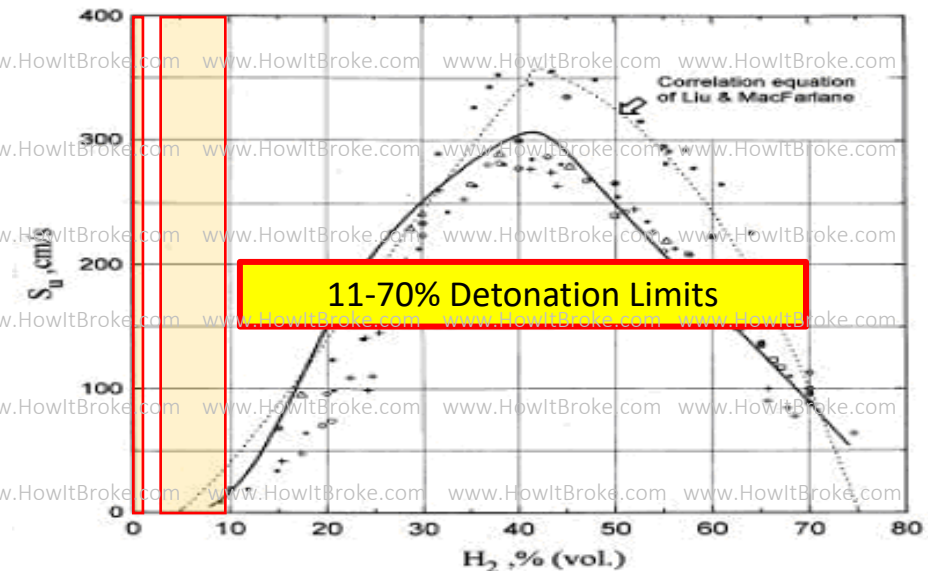
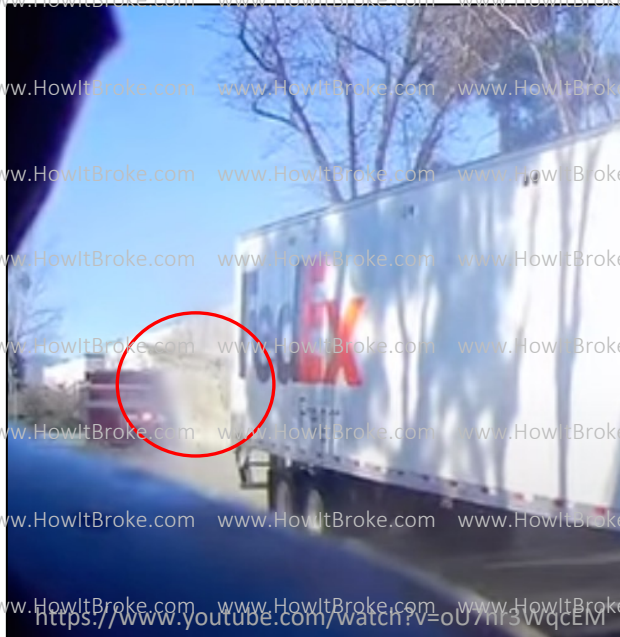
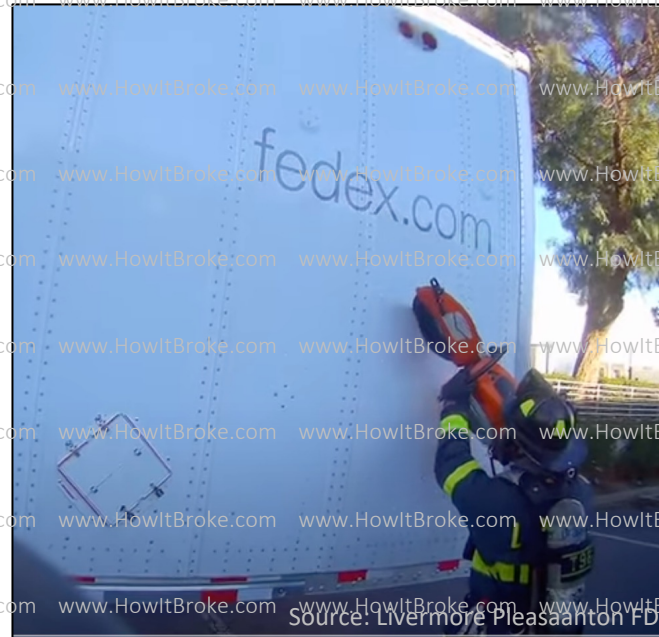
Trailer Door, Livermore Pleasanton, CA, 12/23

Flammability For Livermore Pleasanton Trailer

Limited box(es) of batteries, not sealed drums at front

Trailer Volume: 216/4,035= 5% to 682/4,035= 17%

Volume of flammable gas in trailer

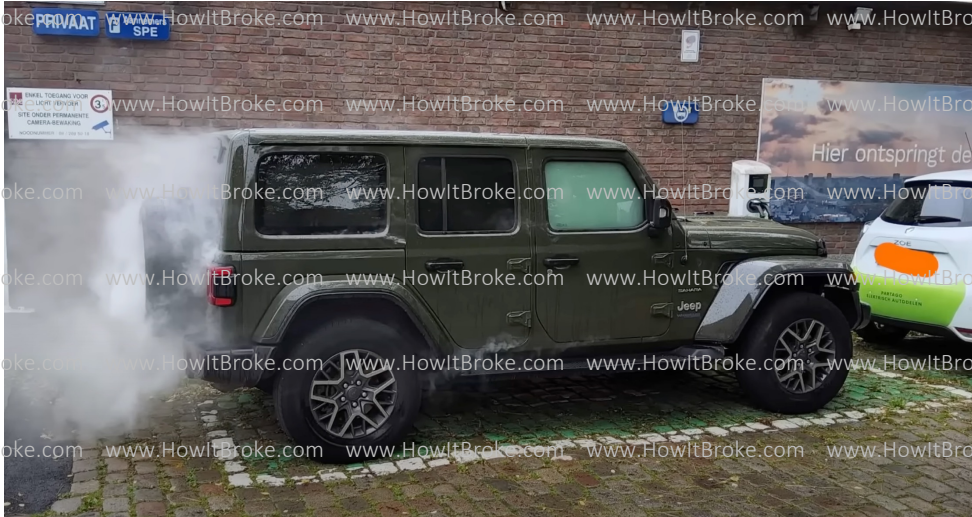
Belgium, October 30, 2023

Jeep Wrangler 4xe Explosions

Cabin Filled With Smoke
Detonated After Breaking Window

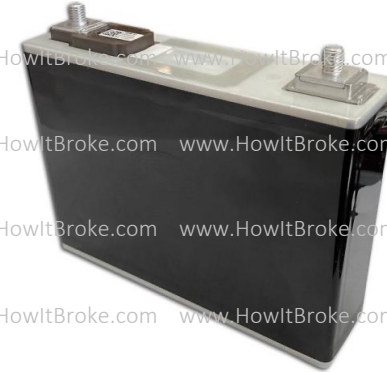
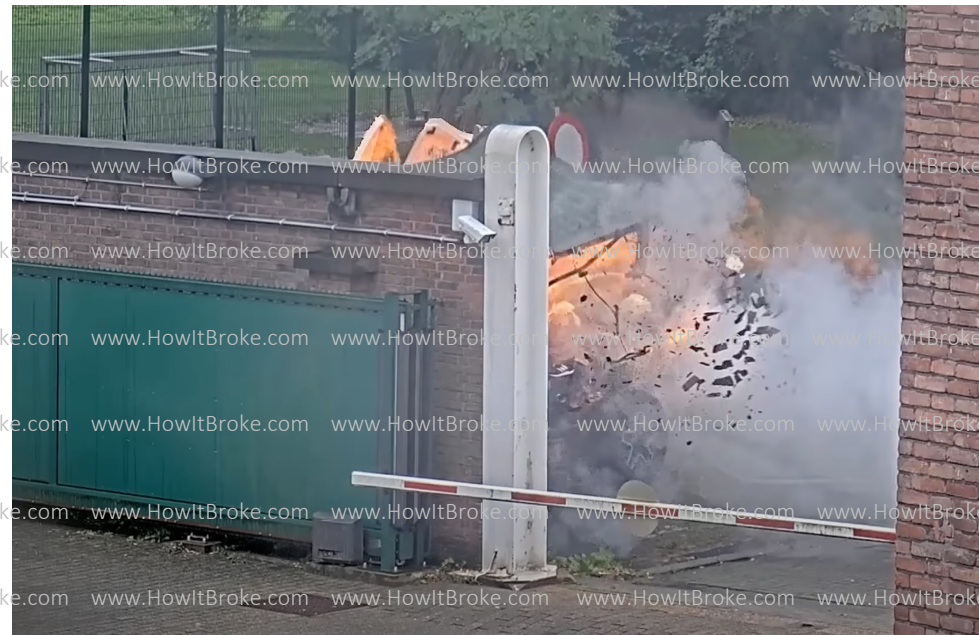
Nine 2021-2023 destroyed
32,125 Vehicles (1%)

NHTSA Recall: 23V-787
Mfg Recall: B9A

Samsung SDI cell lot found defective
96 prismatic cells, Samsung SDI 2700,
94 Ah nickel manganese cobalt NMC cells, 3.7v cell,

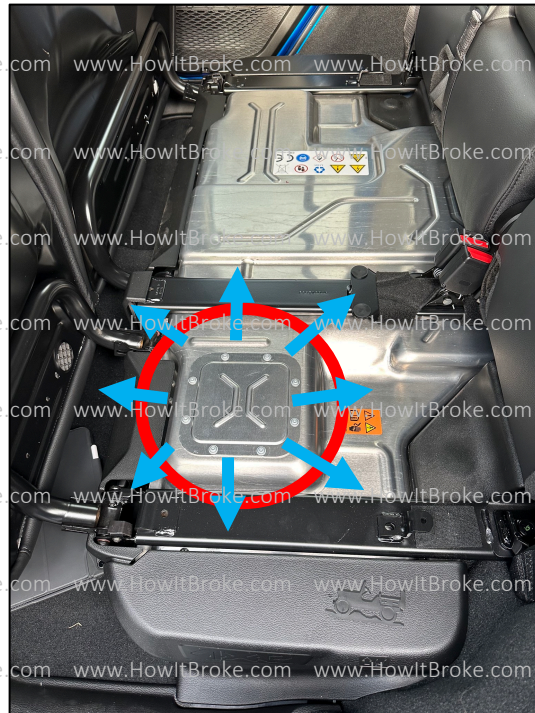
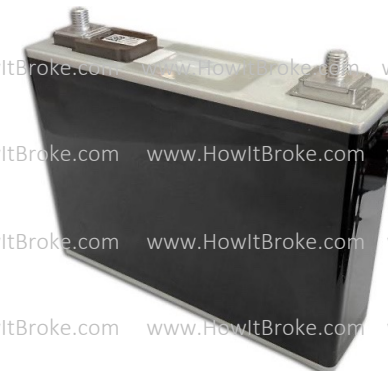
Battery volume = about 255 Liters (9 ft³).
Estimate 90% filled, leaving 25 liters empty volume.

Each cell can produce up to 110 liters (29 gal) of smoke/gas.

Battery case would go beyond UFL almost immediately.
Pressure of gas defeats seal of access plate.
Smoke/gas vents into passenger cabin.

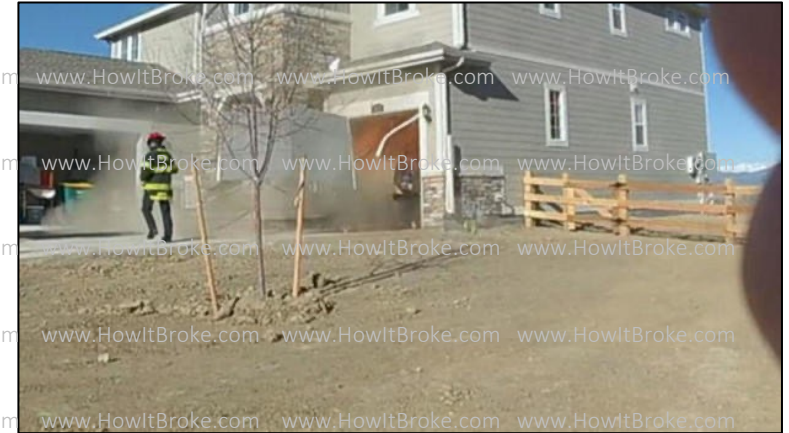
Erie CO, Jeep Wrangler,
Door blown half way
to street, 4/9/2023

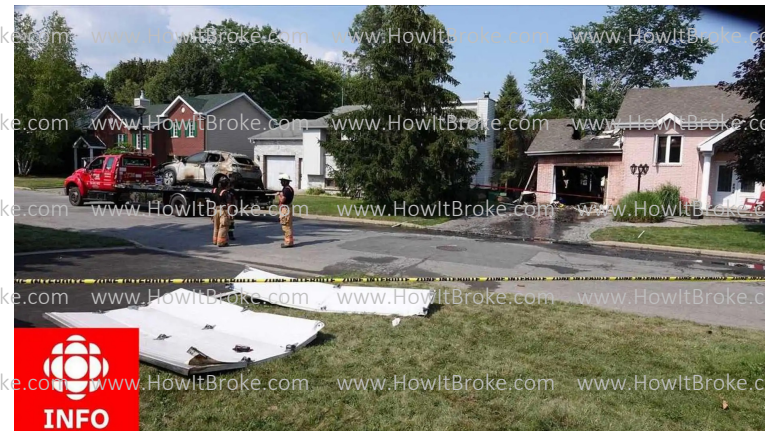
Toronto, Hyundai Kona,
Door blown beyond
street, 7/26/2019

If venting, retreat until sure smoke/gas is not over UFL and/or coming down into flammable/explosive range

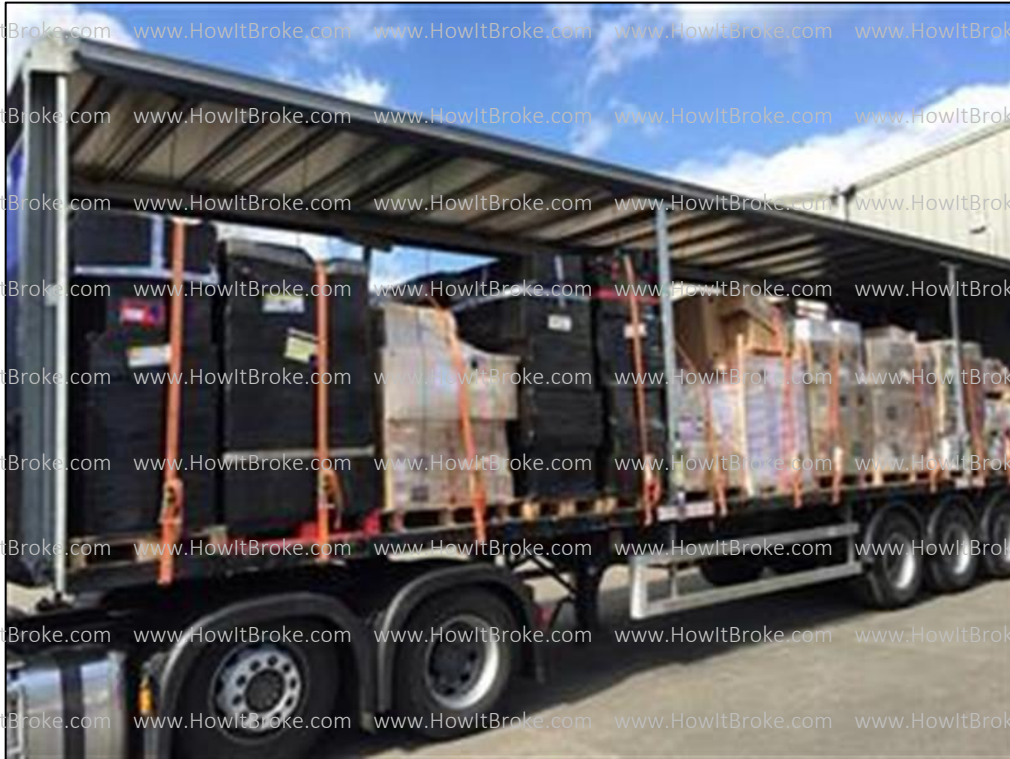
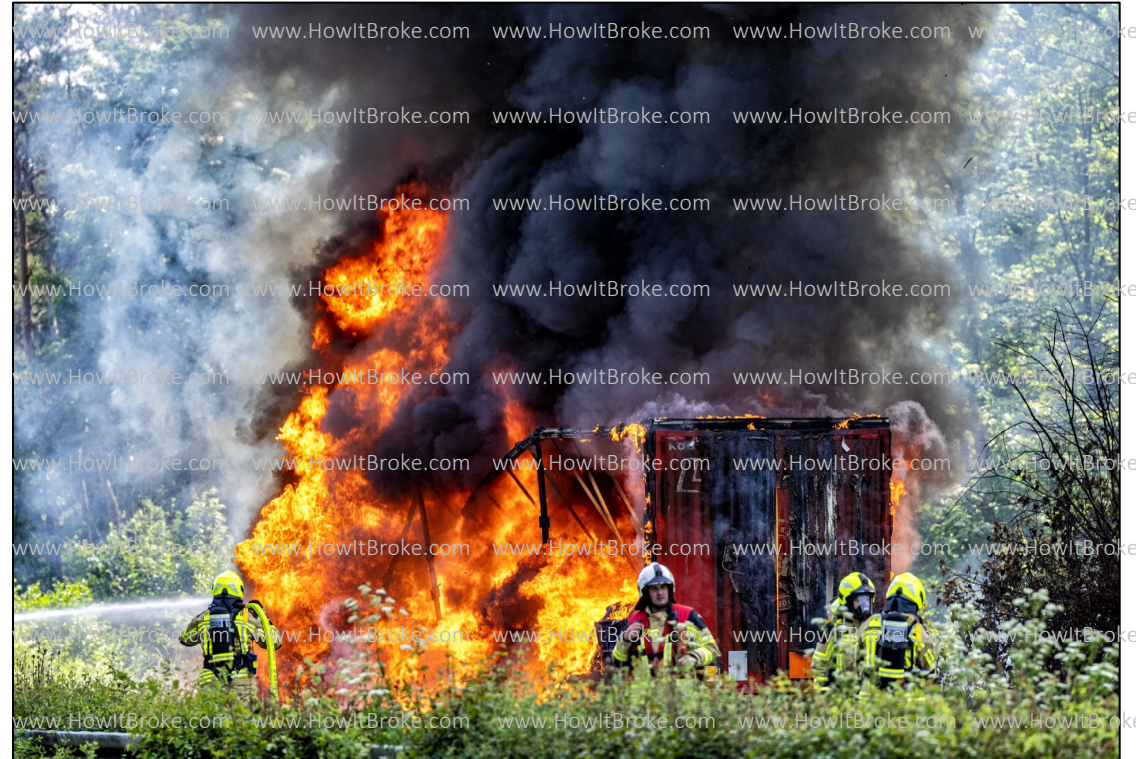
Germany, June 2023

Deflagration venting (fabric sides or top)
Results in fire without explosion
